Riley Restorer

**A magazine for
Riley
restoration
enthusiasts in
Australasia Inc**

June 2023

The Silver Streak power plant by Paul Bae with Phil Wyllie

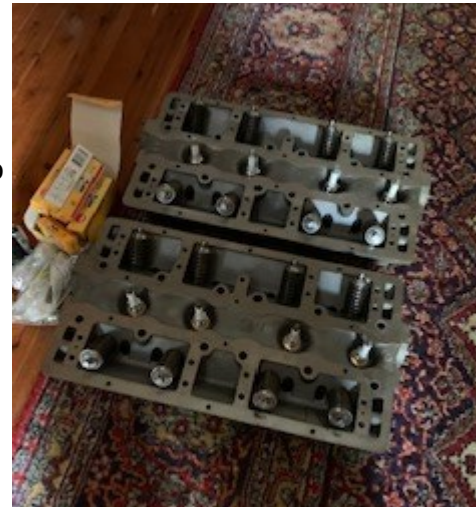
need in order to restore their Rileys. Twenty four new high tensile head nuts were made for the project. The valves are a standard Riley 9 item. Double 12/4 springs with collets were purchased from the Riley Register. They originally began their life as Perkin's diesel components.

Above: The best of the heads with plugs, valves, valve collets and springs fitted.

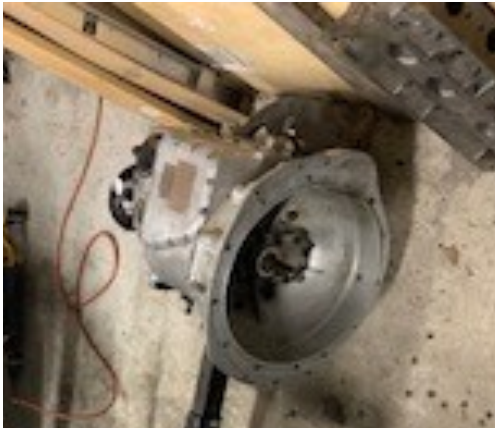
Nothing was done to the gearbox in the hope that it was in good working order. The oil was drained and mono grade 30 Castrol XL was purchased from Castrol's Vintage suppliers in Western Australia.

Above: The gearbox

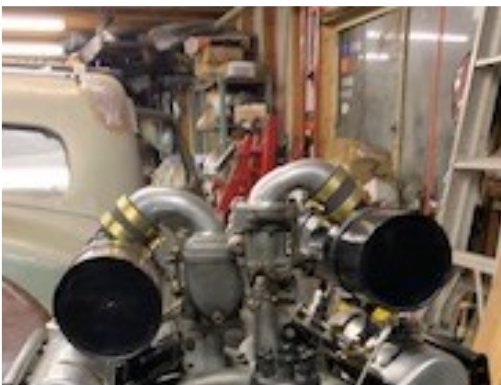
The air box is called a 'Bergas Muffler Air cleaner'. The air was originally designed to enter at the front via a tube. It was perforated and a 'carpet underfelt' material was used to sift the air. Of course this had a long time ago become clogged and there was no simple way of cleaning it. So Paul set it alight and allowed it to smoulder over night until the material was turned into ashes. After cleaning

Above: The air cleaners

and repainting the airbox was fitted with an A5 paper filter that could be easily removed and replaced.

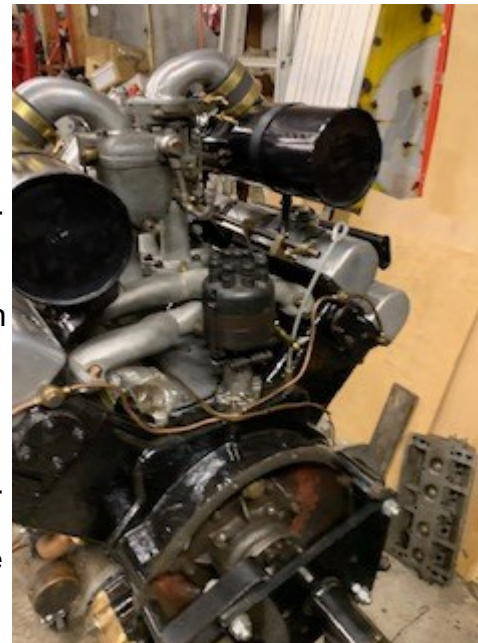
Register offering a V8 engine, valuable spare parts and another gearbox. Out of all of the engine parts there were a sufficient number of heads to make up two good ones for the Silver streak. The best two of the heads was refurbished by a ACT engineer who had considerable experience with Rileys.

Above: A complex assembly

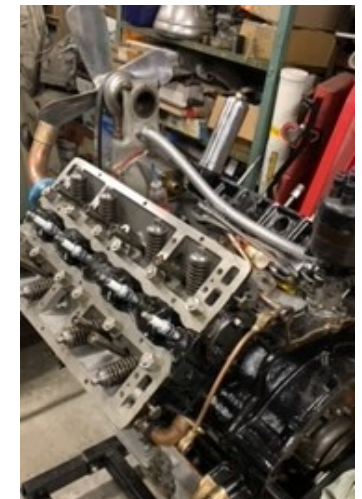
The 8/90 Adelphi engine has multiple gaskets each having its own unique shape. For example, the inlet manifolds each require 8 different gaskets. To get the gaskets, it was decided to have gasket dies made. The dies consist of a rubber

base with a sharp cutting edge that runs around the outside edge and around the inside openings. These are then fitted to a machine that stamps out the gasket shape. In his role as spare parts officer for the NSW club Paul has had dies made for many Riley applications and so the idea of having a die made was not as big a drama as it is for the Riley Restorer editor. The unique thing about these dies is that the gaskets that come from them are unique to the only three or four V8 Riley engines that currently exist in the world. Of particular interest to the editor is the rocker cover gasket. It has a complex shape and is only useful for these unique Riley Adelphi's. The head gasket has been made. The heads have been assembled and are ready to be fitted when the three remaining head studs become available.

Adjacent: The heads trial fitted

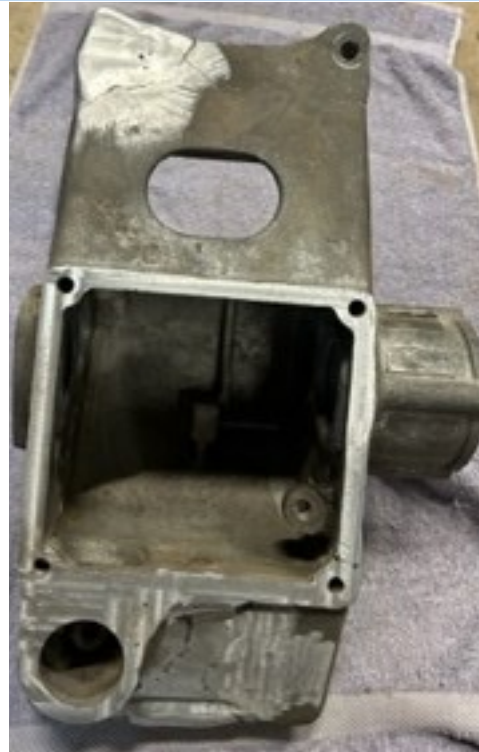
All of the gears, bearings and gear shifting fingers were removed from the gearbox a few months ago. During that time lots of photos were taken to reinforce my fading recollection abilities. When the box was an empty shell, it was taken to a welder who welded new fixing points where the old ones had been. The box had fractured, and the fixing points broken off because the box was originally bolted straight onto the chassis. At home the excess weld on the box was taken off with a mill and the results were cleaned up with the use of a ¼ inch die grinder. The results were very pleasing.

Adjacent: The box cleaned and washed

The box was then cleaned from swarf and washed again with solvents to take off any remaining oil and grit. It was now ready for a rebuild.

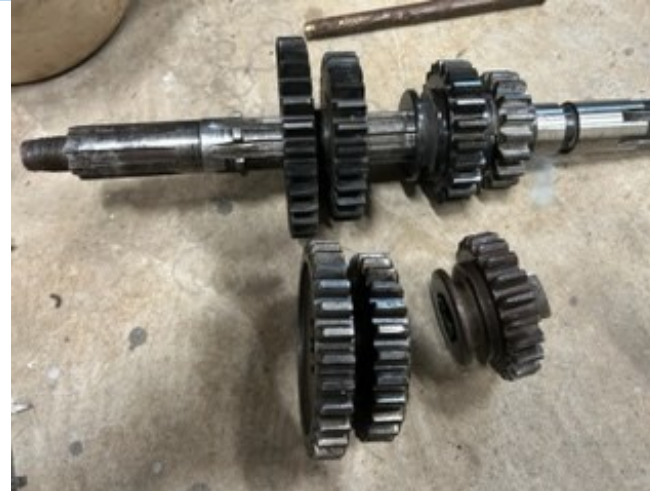
Above: The new main shaft gears are the same as the old ones

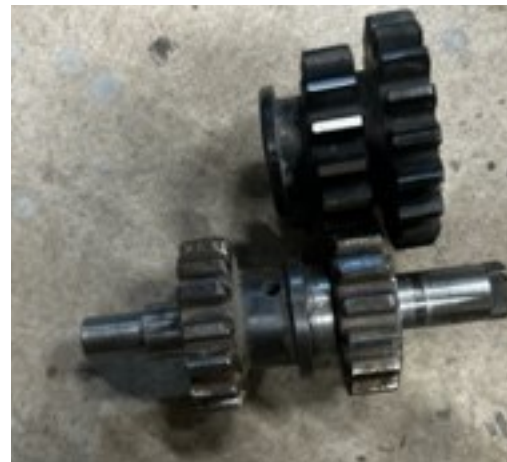
Above: Some clear differences.

One had been made with an internal spline but there were no corresponding parts in my pile of bits. The ODs were different as well. The climactic rebuild that I was expecting after months of preparation and a trip to Melbourne was swept away by the harsh reality of poor communication. What

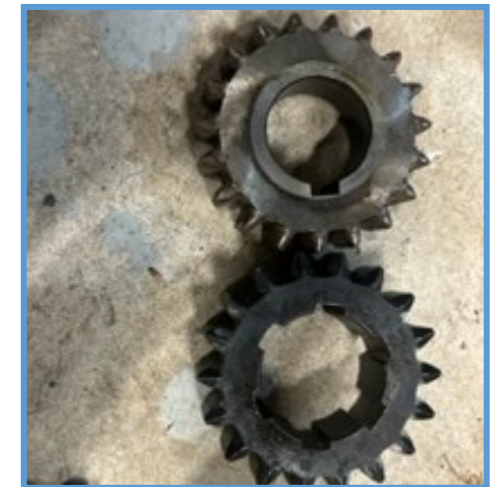
Above: There was no corresponding shaft with internal splines amongst my original parts

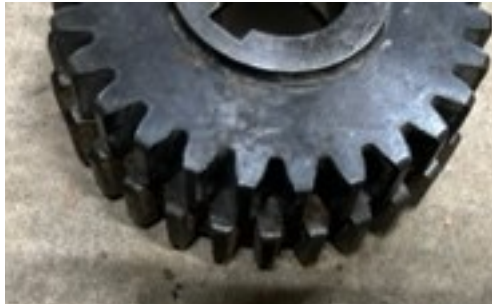
Above: the original and new top gear

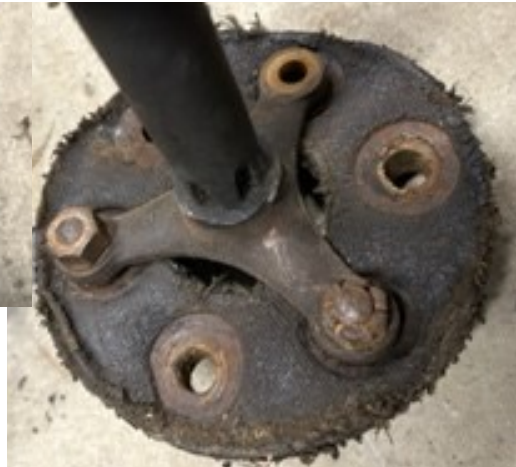
Above: One of the original flexible couplings and adjacent one that a friend made on a CNC machine.

A few weeks previously a conveyor belt assembly manufacturer had been contacted, a length of conveyor belt had been purchased, a friend had cut discs out of the material on a CNC machine

and the beginnings of flexible couplings had been made. These were components used prior to the invention of universal joints.

There are four in the drive train of a SV. One is at the back of the engine and joins it to a propeller shaft that is attached to another flexible coupling at the front of the gear box. There are another two, one at the back of the gearbox and the other at the front of the differential. My next project is to find someone who has a laser machine to cut the fixing washers out that allows you to clamp two coupling disks together and make rigid fixing points for the three fingered drive shafts on either side of the coupling.

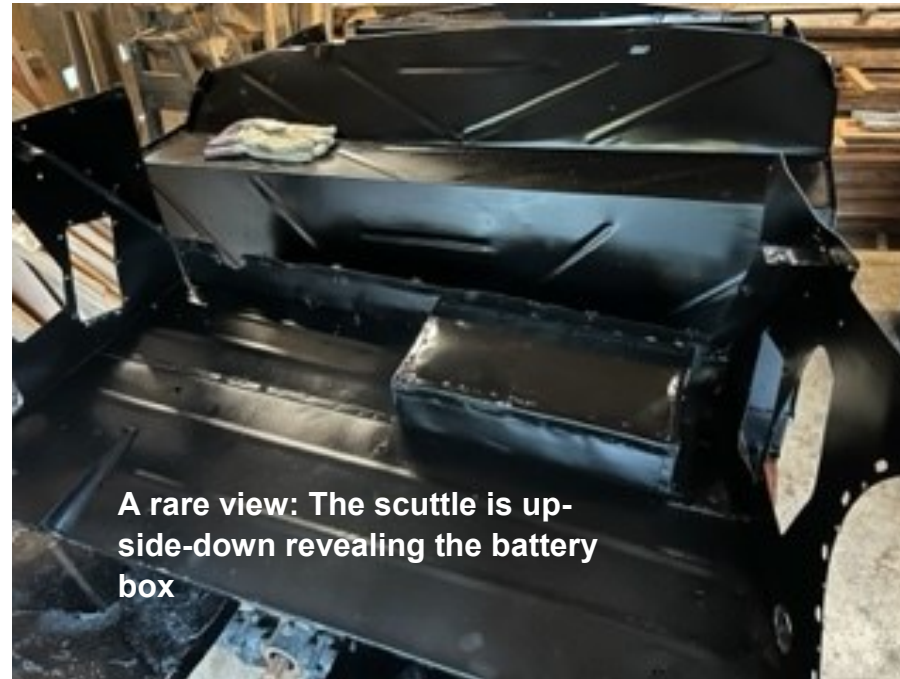
semble but when this was completed the skin went off to a sand blaster and when it came back there were many parts that were see through quite apart from the battery box.

A rare view: The scuttle is upside-down revealing the battery box

The sandblaster put a thin black acrylic undercoat on the skin to 'seal' it but on this occasion it was insufficient so part of this rebuild was etch priming and undercoating all of the underbody parts as well as top coating all the surfaces

that can't be accessed after the body has been reassembled. Patching the body can be done in most places when it is apart so the battery box, the front sill mounts, parts of the floor panels and the

inner skirt for the scuttle were patched. After that all of the hidden areas of the scuttle and underbody parts were sealed and painted with an etch, undercoat and black topcoat.

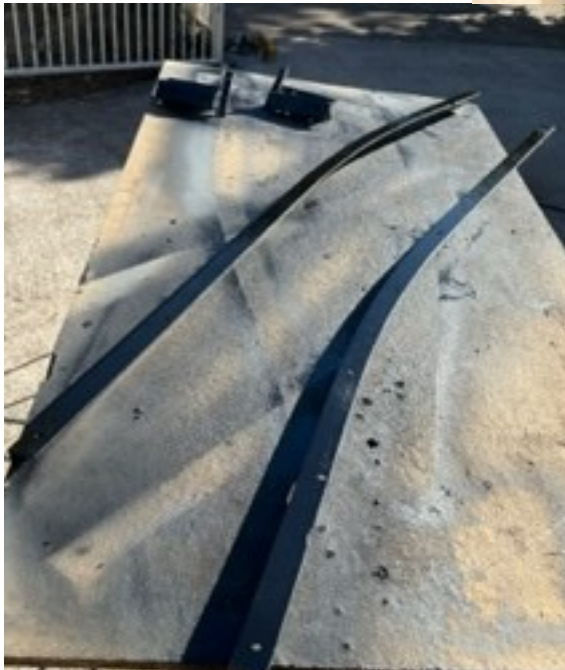
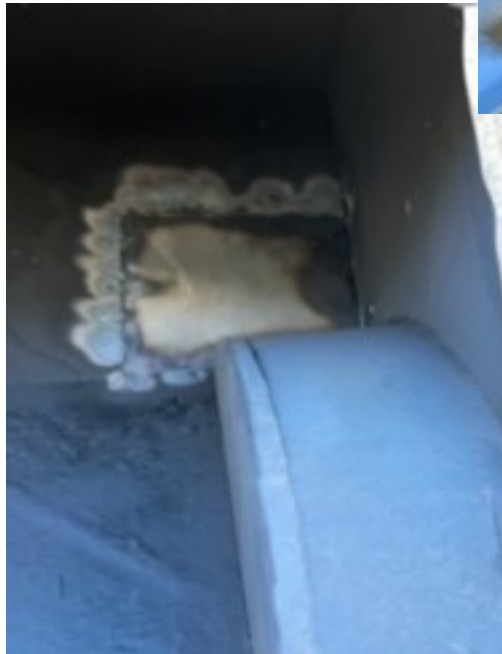
The sills were of course rotten, the dome-headed bolts were rusted down to needle size and the front sill mount largely needed replacing. Replacement timber was in the form of a slab of Flooded Gum. When it was stacked it was 2 inches thick. It dries at the rate of 1 inch per year and over a couple of years it shrinks and depending on its location in the tree, warps and shrinks to about a 45-millimetre thickness. It had been purchased two years previously and had been drying in the workshop ever since. On the sunny coast timber never drops below 14% moisture content so when the roadster goes home to Victoria the timber will lose a little more moisture and maybe shrink an extra millimetre. This was taken into consideration when the timber was thickened, and the thickening brought the timber back to straight boards. The edges were taken off two specimens of slab and they were put through a thickener until top and bottom was flat and un-encumbered with knots or splits. A template was used to mark the outside shape and the timber was passed through a band saw.

Above and adjacent: The angle iron sill edging and the front supports cleaned and new steel welded into them

The front support had mostly rusted away and required new steel where they were bolted to the sill. The packing material under it was a chipboard and the steel sitting on it was rusted away as well. Replacement packing that is currently being used is a synthetic material used to make drain pits. They probably have a half-life of several Riley custodian's lifetimes. The material can be purchased in sheets and cut to size on a band-

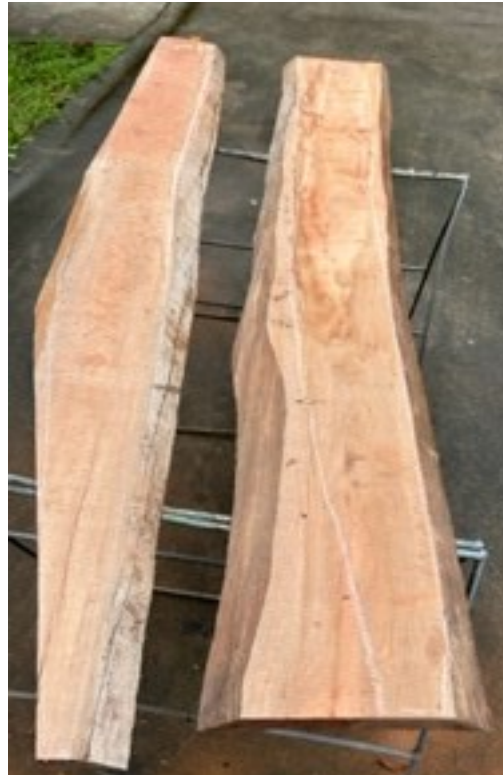
The new sills were painted with a water based paint and this was allowed to soak into the timber,

the result was painted again with a marine varnished sourced from the timber boat fastener suppliers. This was painted again with an oil based brown paint that looked similar to the original timber colour.

Above The sills can be imagined in the timber

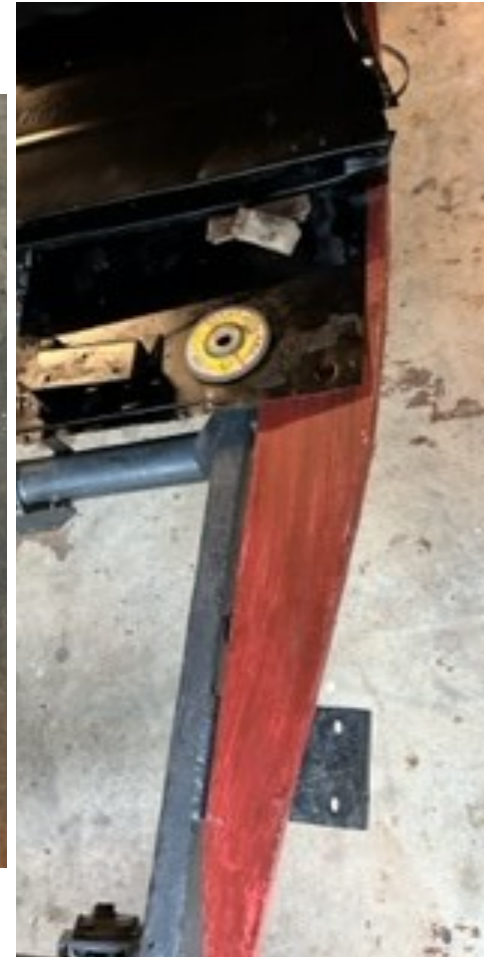
The sill were drilled and the angle iron fitted using tapered stainless steel bolts. The front steel support was fixed into position with round

Above: The passenger side sill thickened, cut out with a band saw, painted, and angle

iron fixed into position with stainless steel bolts.

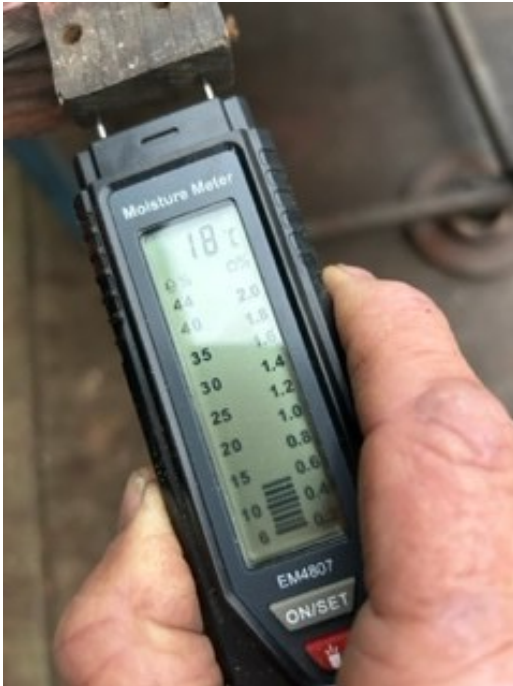
The moisture meter indicates that the timber moisture level is 15%.

On the Mouldy (sunshine) coast and in Rainy Maleny the lowest levels that can be achieved is 14% but out west it can drop as low as 10 to 12%.

Above: The prongs of the moisture meter are pushed into what was left of the original rib.

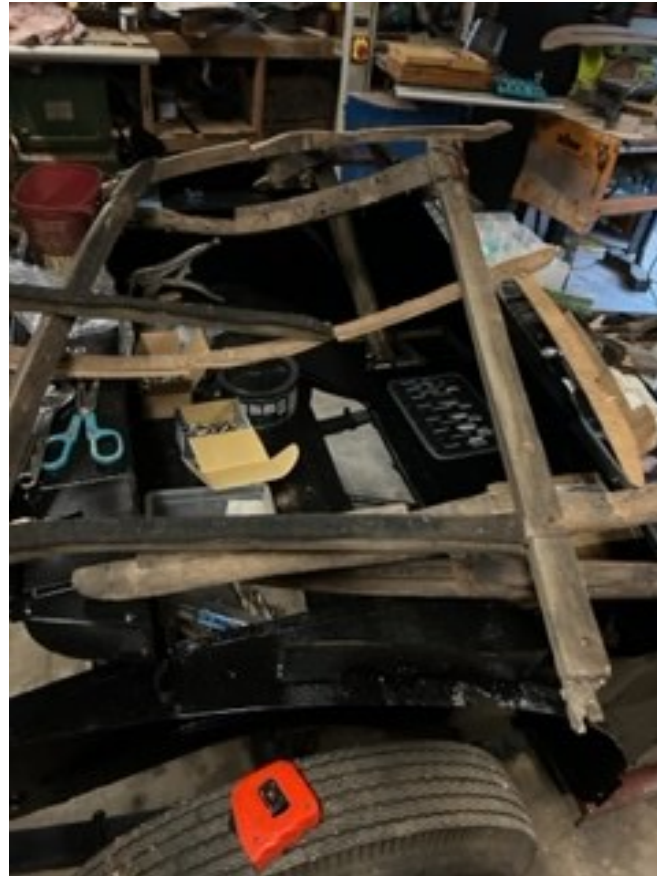
Arrayed around the roadster are samples of the timbers used and lots of finger prints. Some of the timbers are originals taken from roadsters during re-building and the others are not yet used.

Patterns may be seen around the roadster but they vary from one vehicle to another and significantly from one version of the roadster to another. The one pictured shows samples of the timbers with variations of up to 1/2 inch on the central rib.

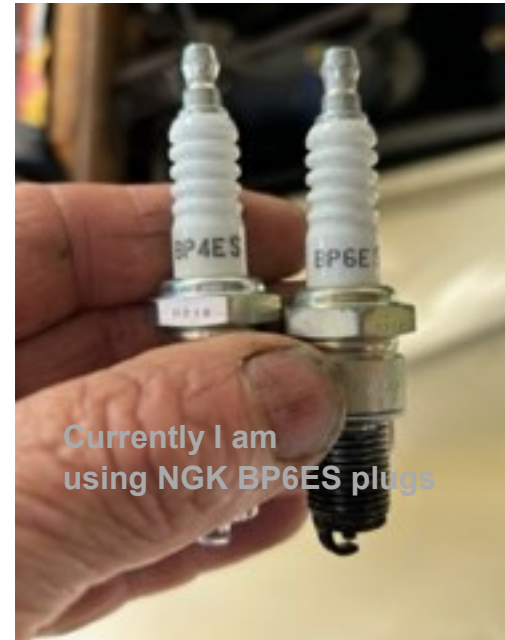
Currently I am using NGK BP6ES plugs
