Riley Restorer

**A magazine for Riley restoration enthusiasts in
Australasia Inc July 2023 www.riley-restorer.com**

The worst job on an RM Riley (yukky and mandrel photos courtesy of Paul Bae)

RMB Fuel tank adventures by Iain Robilliard

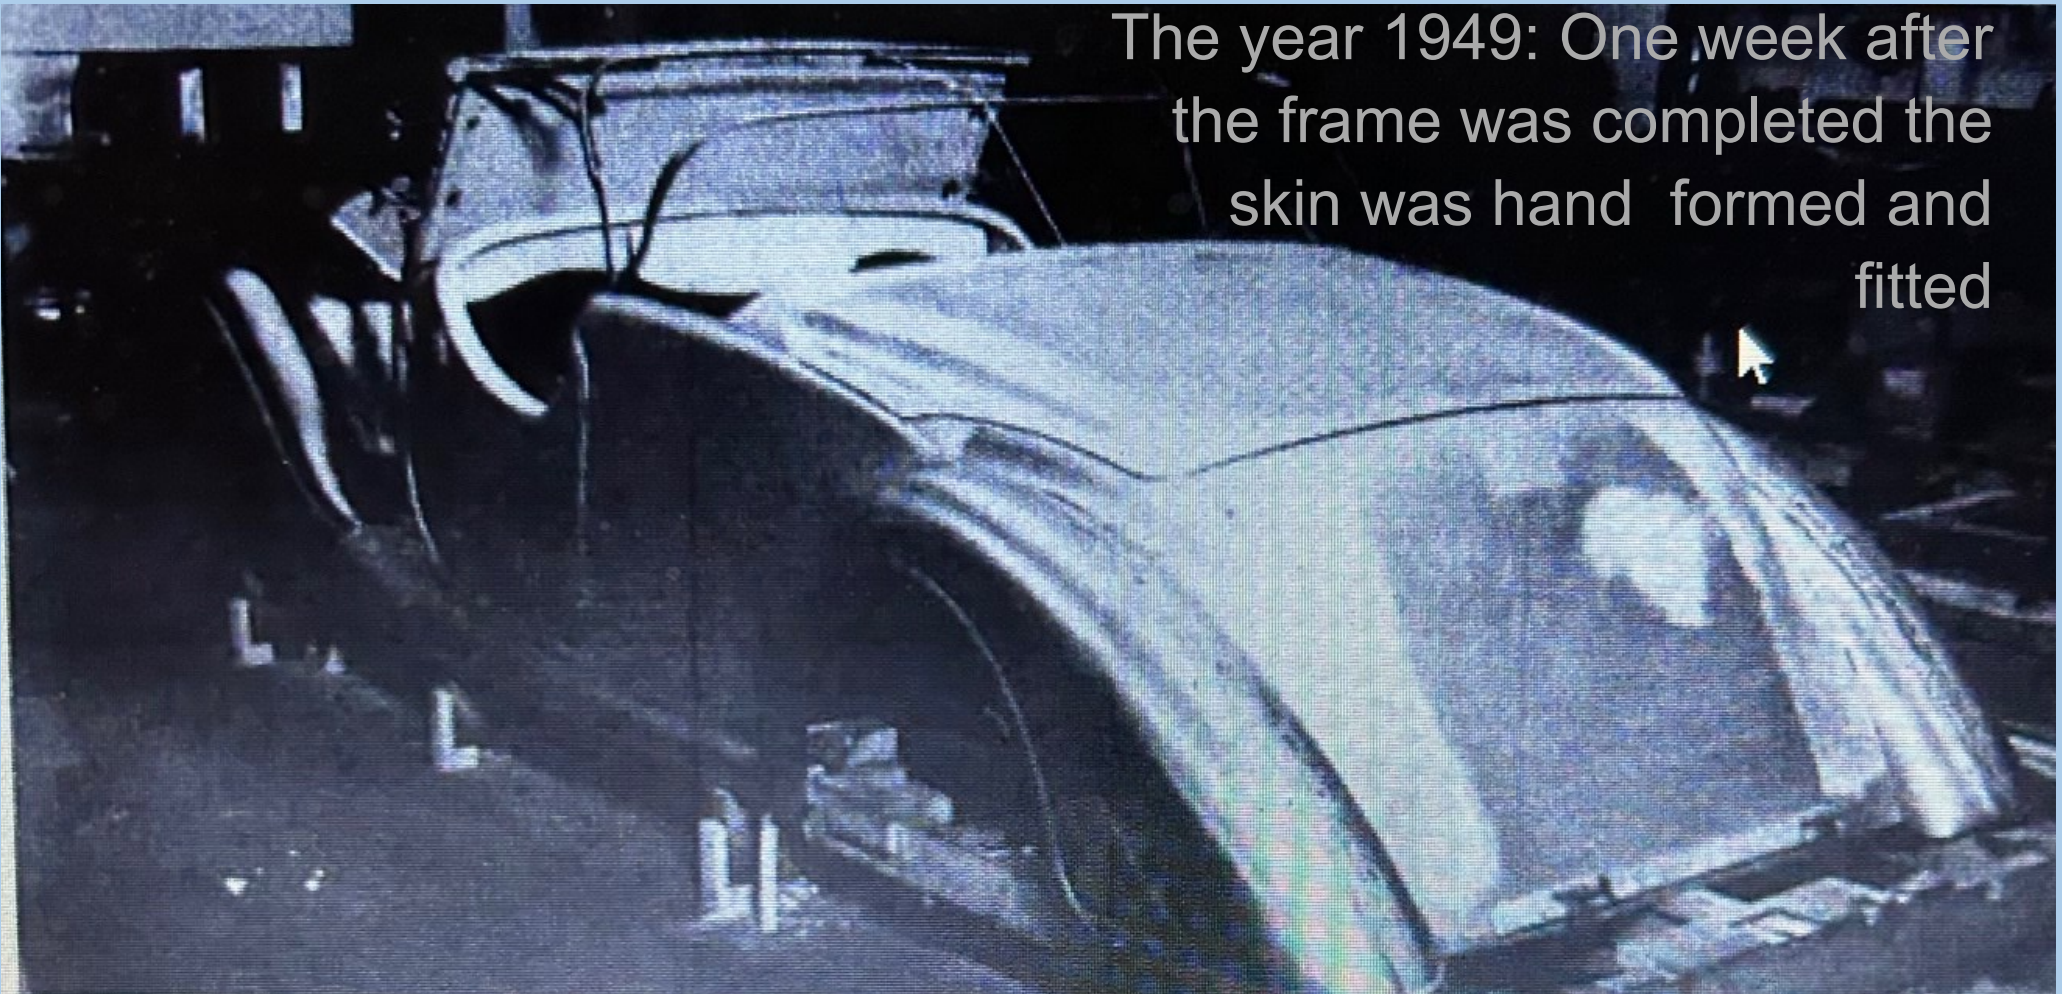
The year 1949: One week after
the frame was completed the
skin was hand formed and
fitted

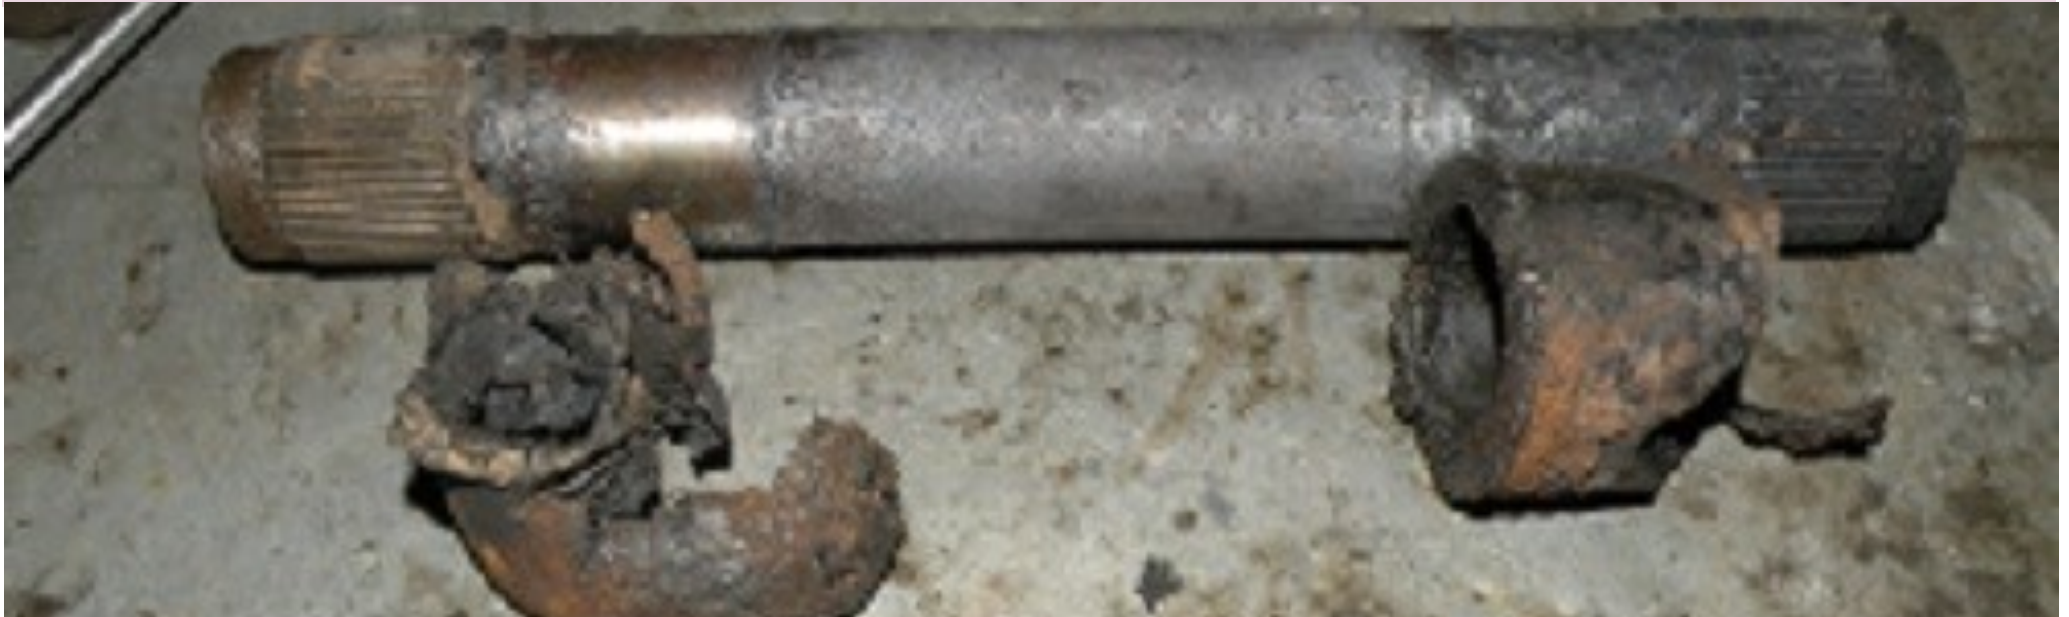
That is how it was described to me. It is particularly difficult if you try to do the job while the engine cradle is still in the Riley. What job is it? Changing the torsion tube rubbers in the engine cradle. It is nowhere near as hard if the cradle is out of the Riley, but it still requires the right tools and experience. But who would change the torsion tube rubbers while the engine cradle was still in his Riley? Paul Bae of course. Before describing the easier option a brief description of what he did may be of interest. Two tools were made, a mandrel for pushing the torsion

tube and old rubbers out and another mandrel for pushing the new ones in. In his case as well as mine the wheels, suspension arms and torsion bar fixing parts were removed. The torsion bars were bumped out ensuring they were carefully marked but not scratched identifying the side from which they were drawn. It is absolutely important at this stage to remove the two retaining bolts that hold the sleeve in place and this is what Paul did. From the first picture you can see that the re-

With the tubes and rubbers out the area was cleaned and painted. New rubber bushes were pushed into place without lubrication. The

inside surfaces of the rubber bushes were lubricated with rubber grease and with the use of the second mandrel the lubricated tube was pushed back into place. The activity may not have been easy but without doubt most of the rust and crud were successfully transferred from the Riley onto Paul so be smelt like a Riley. Mis-

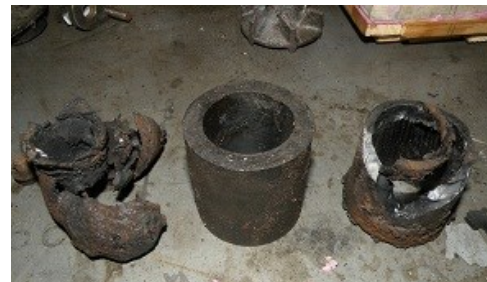
Above: Old and new torsion tube rubbers and tube

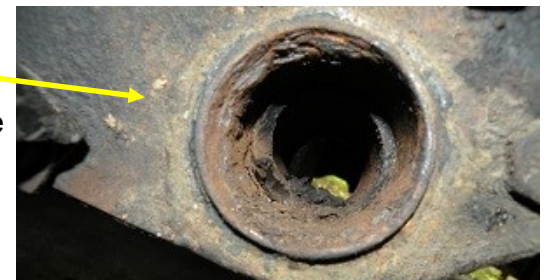
After the torsion bars, suspension arms and the assembly for fixing the torsion bars were taken off the Rileys the two courses taken to replace the torsion bar rubbers were quite different. As said, Paul did not take his engine cradle out of the Riley. Instead he employed a mandrel to push the tube and rubbers out.

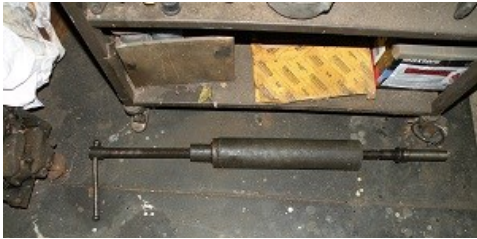
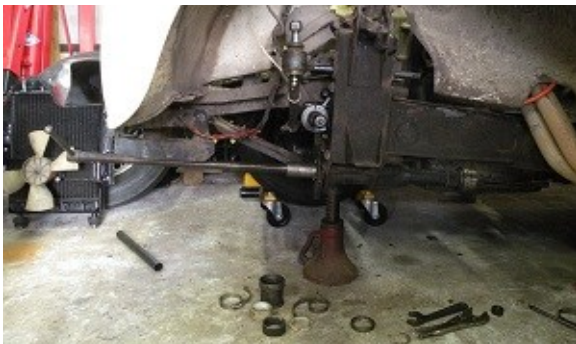
**Above: Removal mandrel and
Below: Insertion mandrel**

I borrowed his mandrels and found it an impossible task. Even with an extension bar there was not enough strength in me to shift the first tube very far. The rubbers just don't want to let go.

But with a combination of Paul's youthful strength (you need a lot of that) a strong will and an oxyacetylene torch the job can be done. Clearly, Paul took great care to ensure that the Riley did not combust..

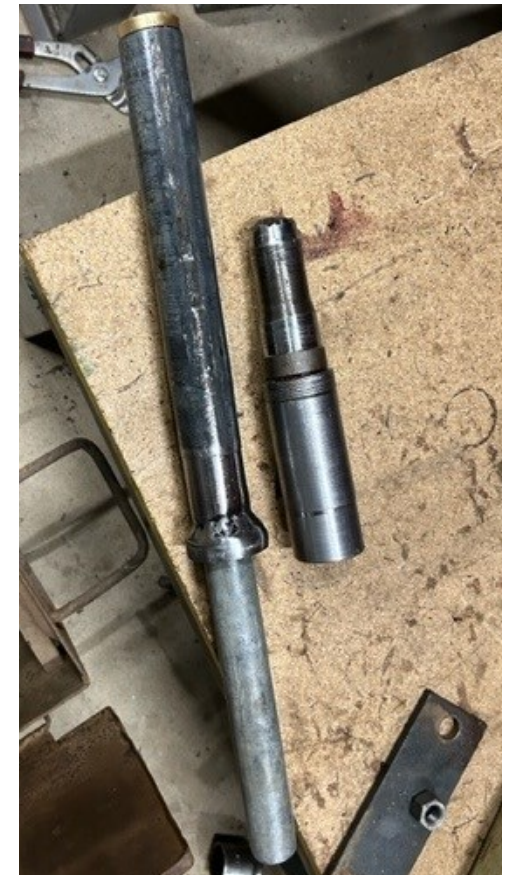
Pushing and centering tools

The sleeve in the engine cradle was pushed into place and the retaining bolts were screwed into it to secure it. The rubber bushes were fitted into either end of the engine cradle tube without any lubrication on the outside surface of the bushes. This was to help them remain in place while the torsion tube was pushed through them.

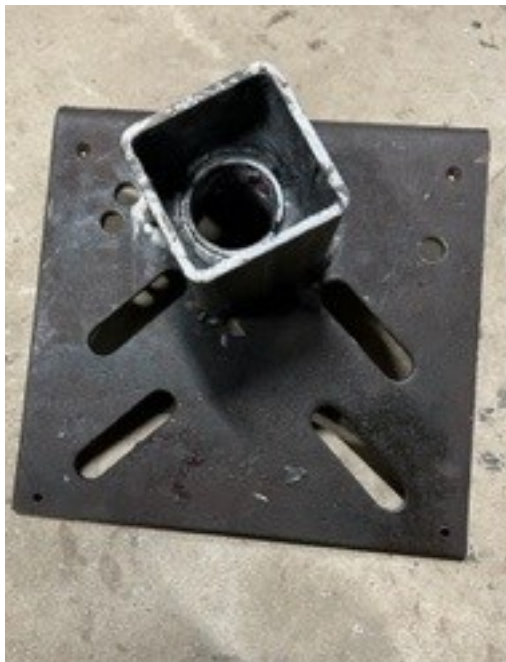
A cradle was made for the other side of the outer torsion bar tube. It was made with a tube that would fit over the other end of the engine cradle outer tube. The cradle needs an outer sleeve to help keep the engine cradle tube in line with the shop press. A round pipe of the size required could not be found so a square tube was purchased. In the end it worked well as it also fitted over the top of the sleeve retaining bolts. It was cut to the length of the torsion bar tube so it fully fitted into place.

It was also found that an inner sleeve needed to be made as a stop for the rubber bush. One of the exact size was not available so two pipes were purchased, one fitted inside of the other and these were welded together. Later, it was found that a third pipe was useful. The stop's only purpose is to hold the torsion bar rubber bush in place so it cannot escape while the torsion bar tube is pressed into place. The space between the outer square tube and the inner tubes was filled with an epoxy resin to prevent the rubber from escaping over the pipes that were welded together. This assembly was welded to a base plate that fitted onto the adjustable shop press table. The plate that the tubes were welded to was fixed into place so that when the torsion bar tube was being pushed through the rubber bushes the cradle was kept in alignment and the tube was kept perfectly straight. The square tube was fitted over the runner stop tubes and welded onto the plate so that one of the corners fitted over the sleeve retaining bolt.

Three holes were drilled through the base plate on either side of the engine cradle base and over the top of one of the bolt holes in the cradle that is used to fix it to the chassis. A plate was drilled that fitted over the base of the engine cradle and received two of the threaded rods. Threaded rod was passed through the holes in the base plate, through the bolt hole in the cradle and through the plate that fitted over the top of the cradle base. Nuts and washers were screwed onto the bottom and top of the threaded rod fixing the engine cradle securely to the base plate. The purpose of fixing the cradle to the base plate and into the torque tube cradle that had been made was to prevent the engine cradle from riding up the bottom rubber bush

when the torque tube was pushed into position. This was found to be absolutely necessary so the rubbers were retained in their positions during the fitting operation. PS: The tubes fit with the internal spline at the rear

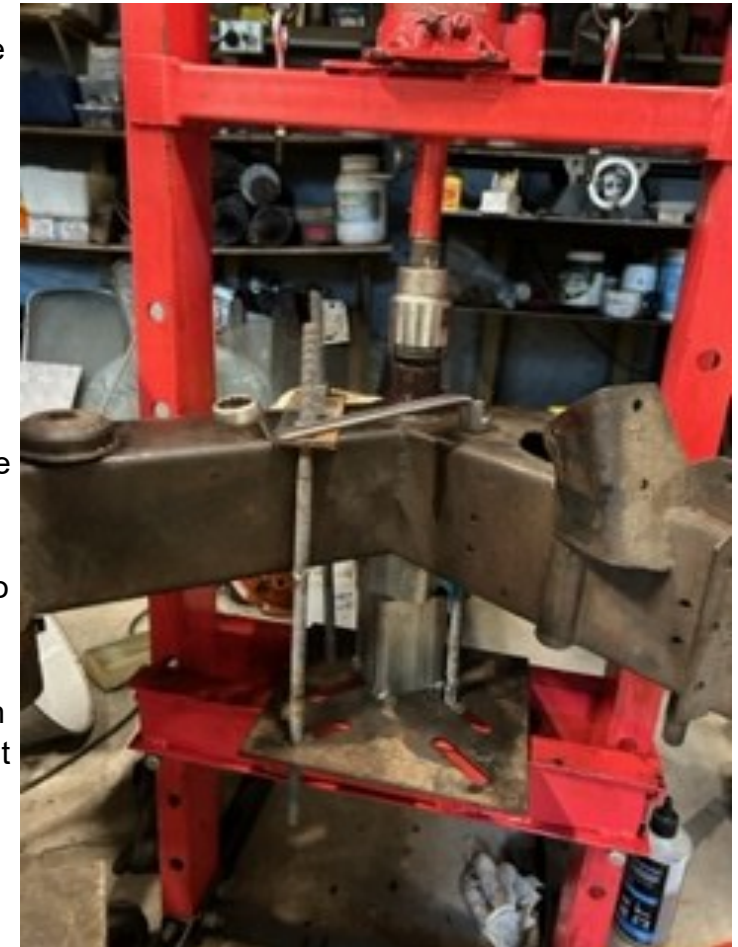
Below: The rubber bushes trapped in their place to prevent any possibility of an escape.

The rubber bushes were pushed into place on either side of the inner sleeve dry – that is no rubber grease was used to fit them. This is to help the bush remain in place. The inside of the rubber bushes and the torsion bar tube and splines were then liberally coated with rubber grease. The

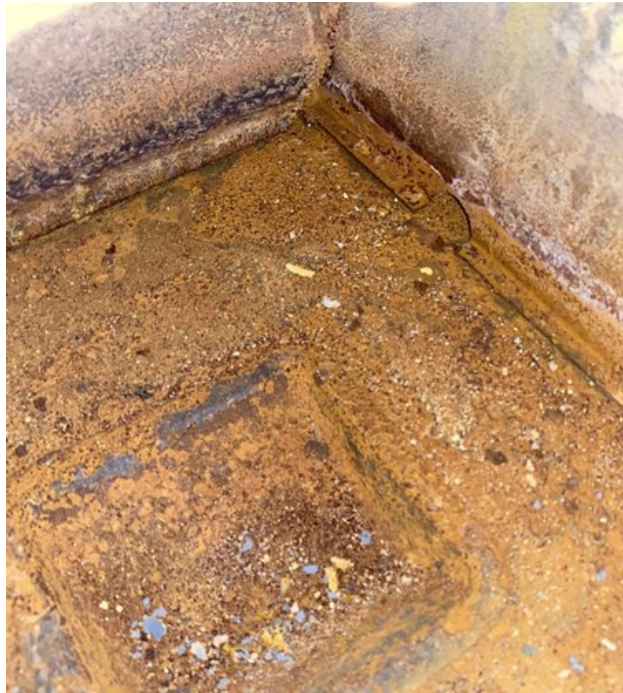
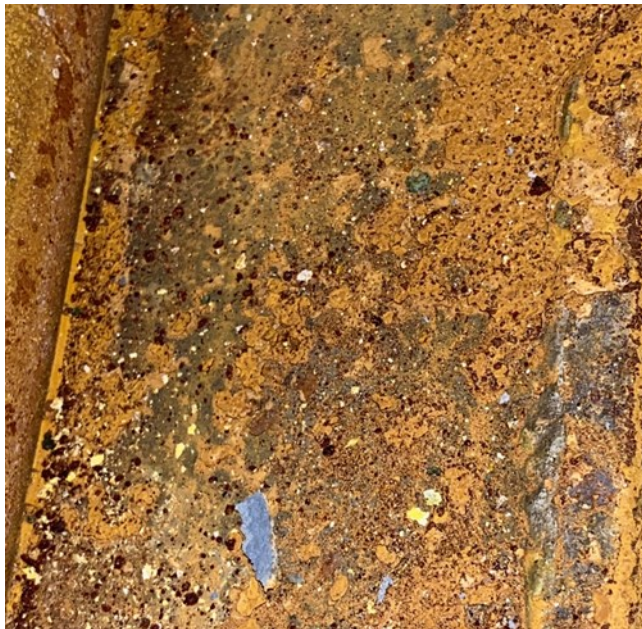
Below: This is the mess inside the tank at the beginning of the Evaporust process. A mix of rust materials and fuel deposits, probably better shown in a closeup shot of part of the surface.

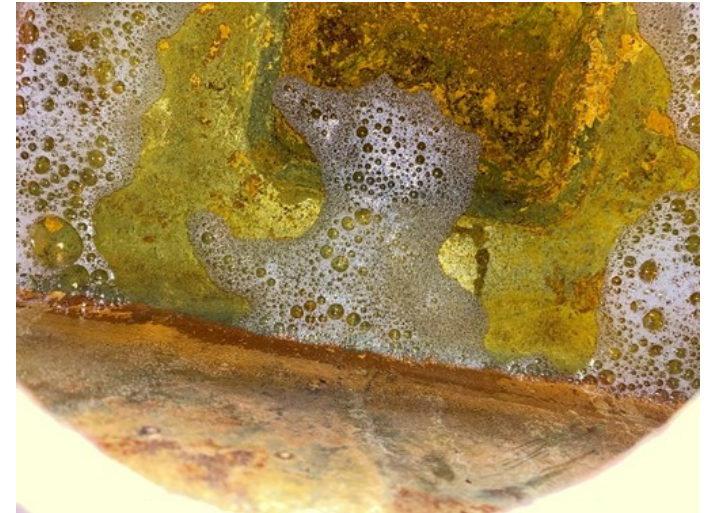
Below: This shows the Evaporust working with the first 5 litre test lot. The bubbles are from sloshing the tank around, not a gas producing reaction.

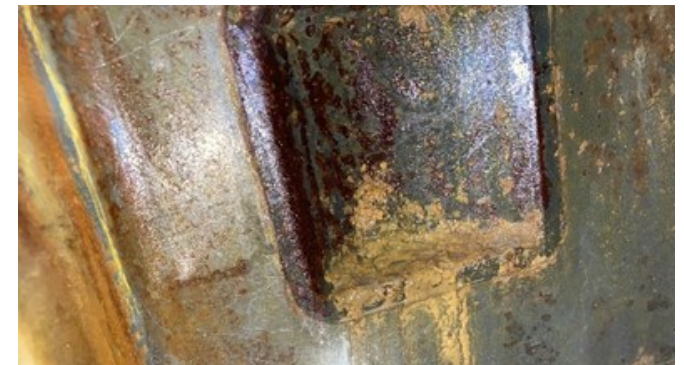
Below: This shows the sludge formed by the reaction of the hardened fuel deposits with the Evaporust flowing off the tank surface during one of the several drain and filter the fluid processes. Still some rust to go..

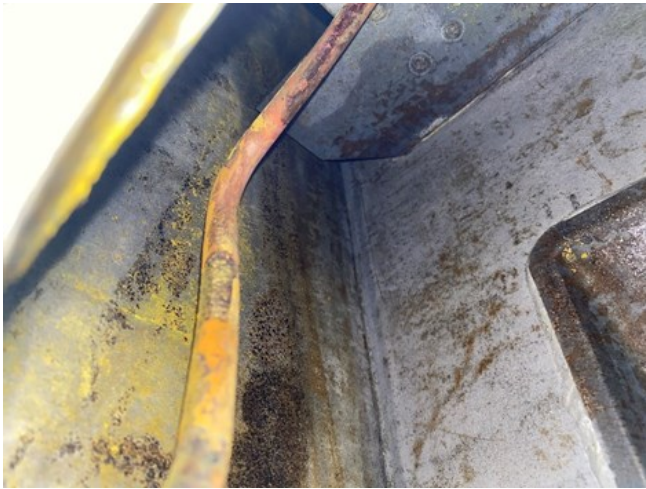
Below: Still going: a dramatic improvement but not finished.

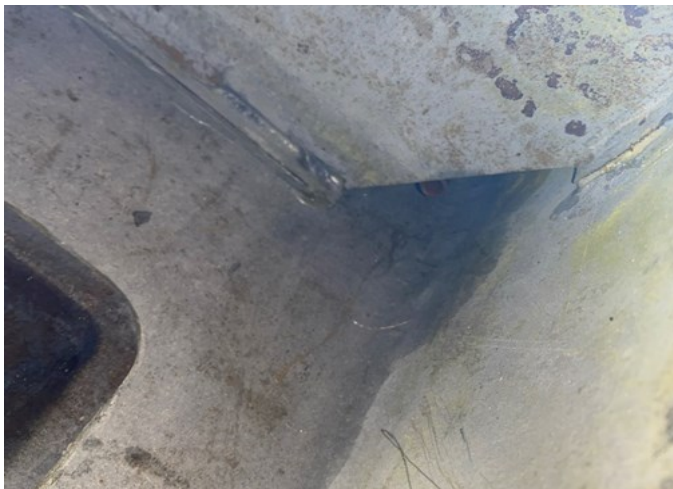
The point of stopping. By this stage I was bored silly by the process. Any corrosion remaining was judged inconsequential given the corrosion protection properties of modern fuels, and the intent is to keep the vehicle tank as full as practicable, refuelling after an event rather than prior.

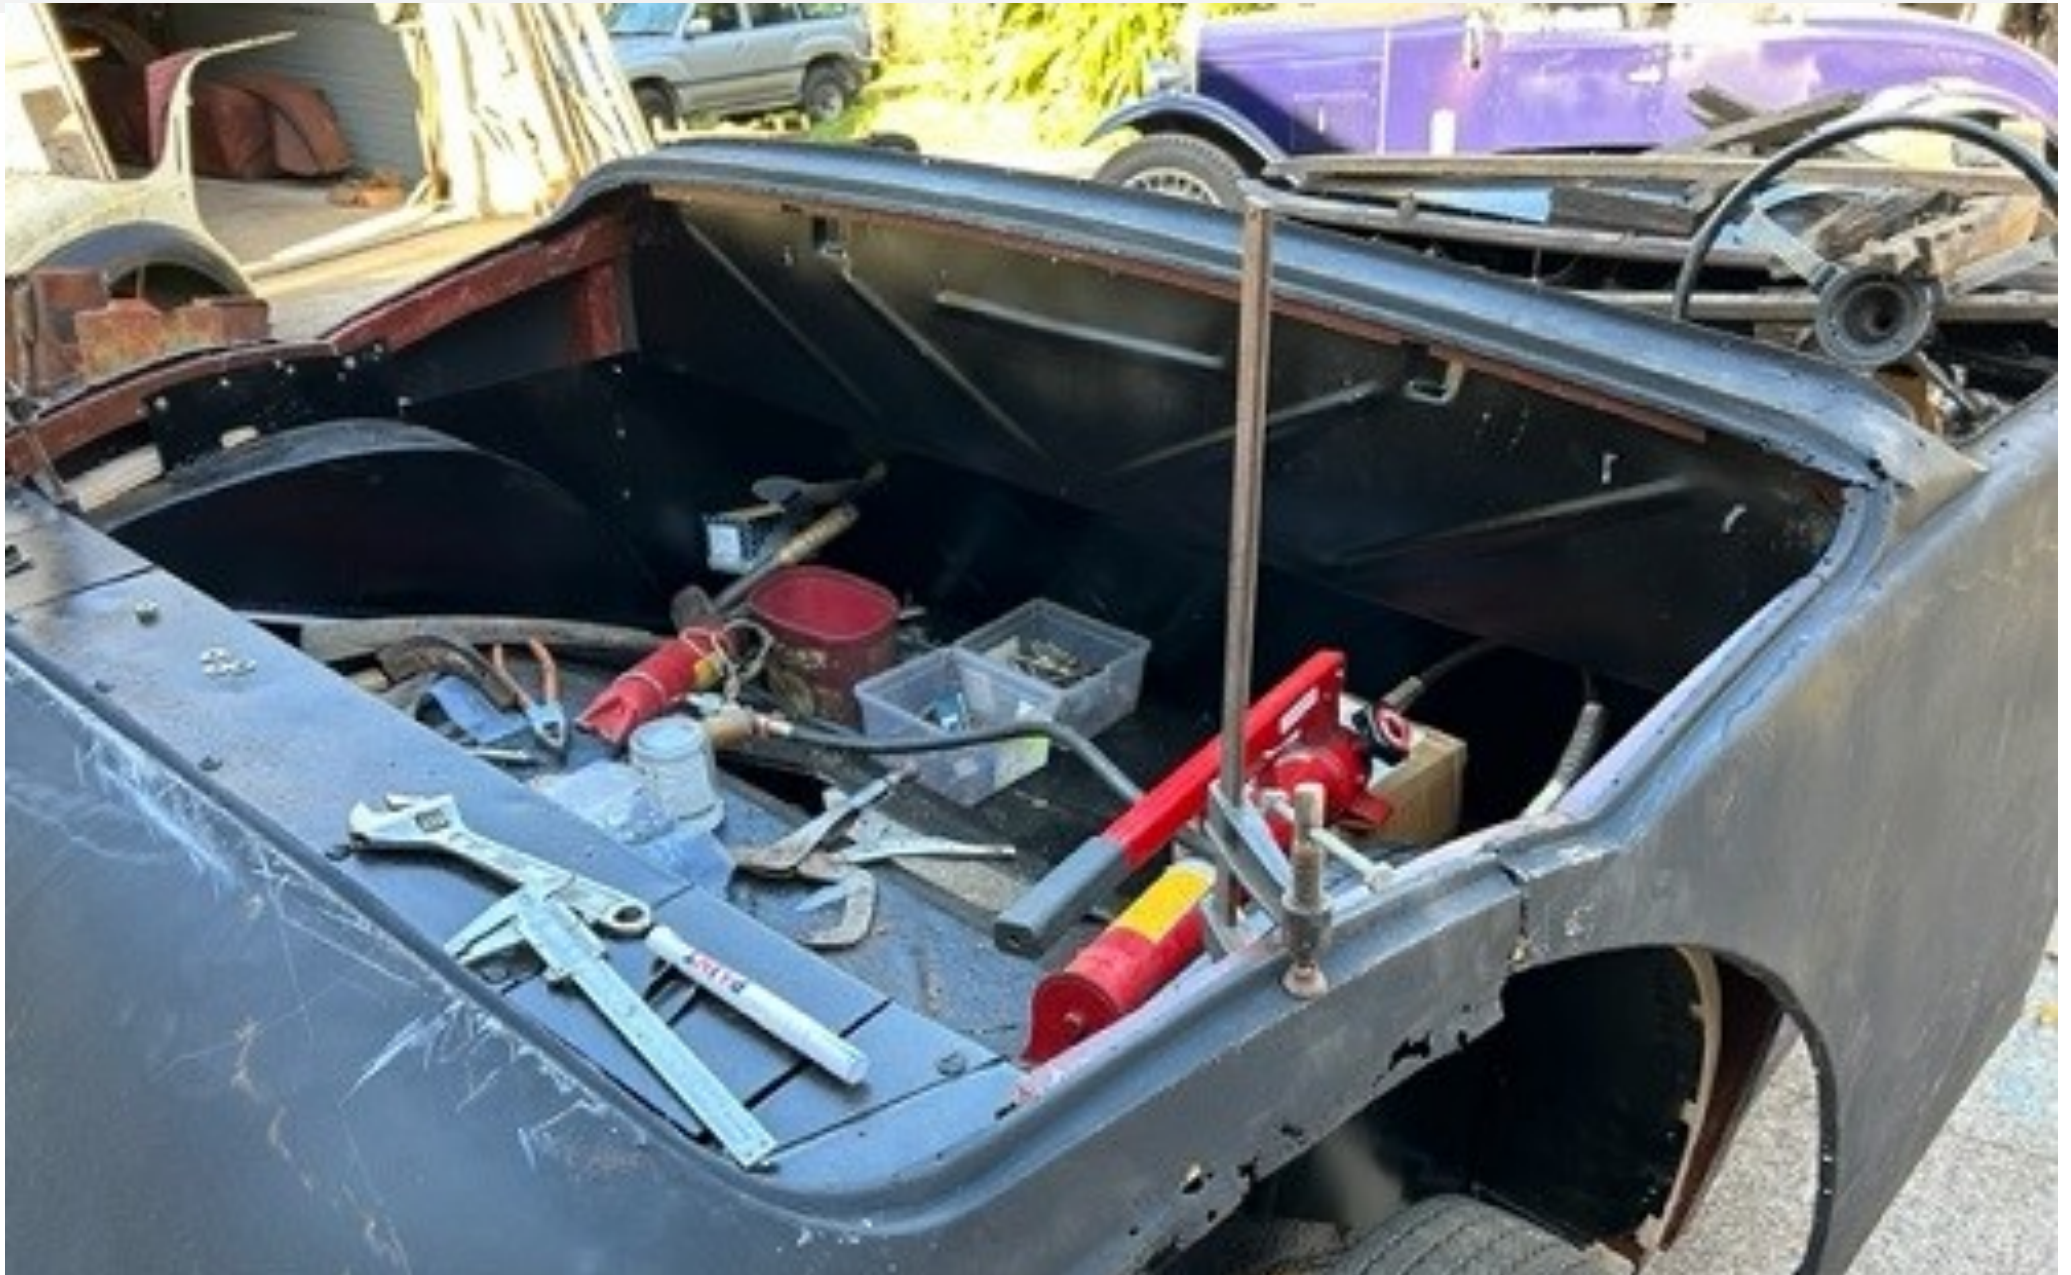
The centre page lift out: RMC reframed and outer skin trial fitted

These were screwed together with stainless steel screws. With the timbers in place, it was time to trial fit the outer skin. This was made a little difficult as the thin area adjacent to the boot opening had rusted away completely. In the first instance the ends were welded together so the skin could be fitted. That was sufficient for the trial fit but there was so much contamination in the metal it was decided to remove that section and replace it with new steel.

It was really the first time that the skin was looked at with a critical eye and what was discovered was not surprising. The skin on the sides had rusted out and instead of cutting the rust out and butt welding new pieces in, steel was laid over the top of the rusted areas and lap welded into position.

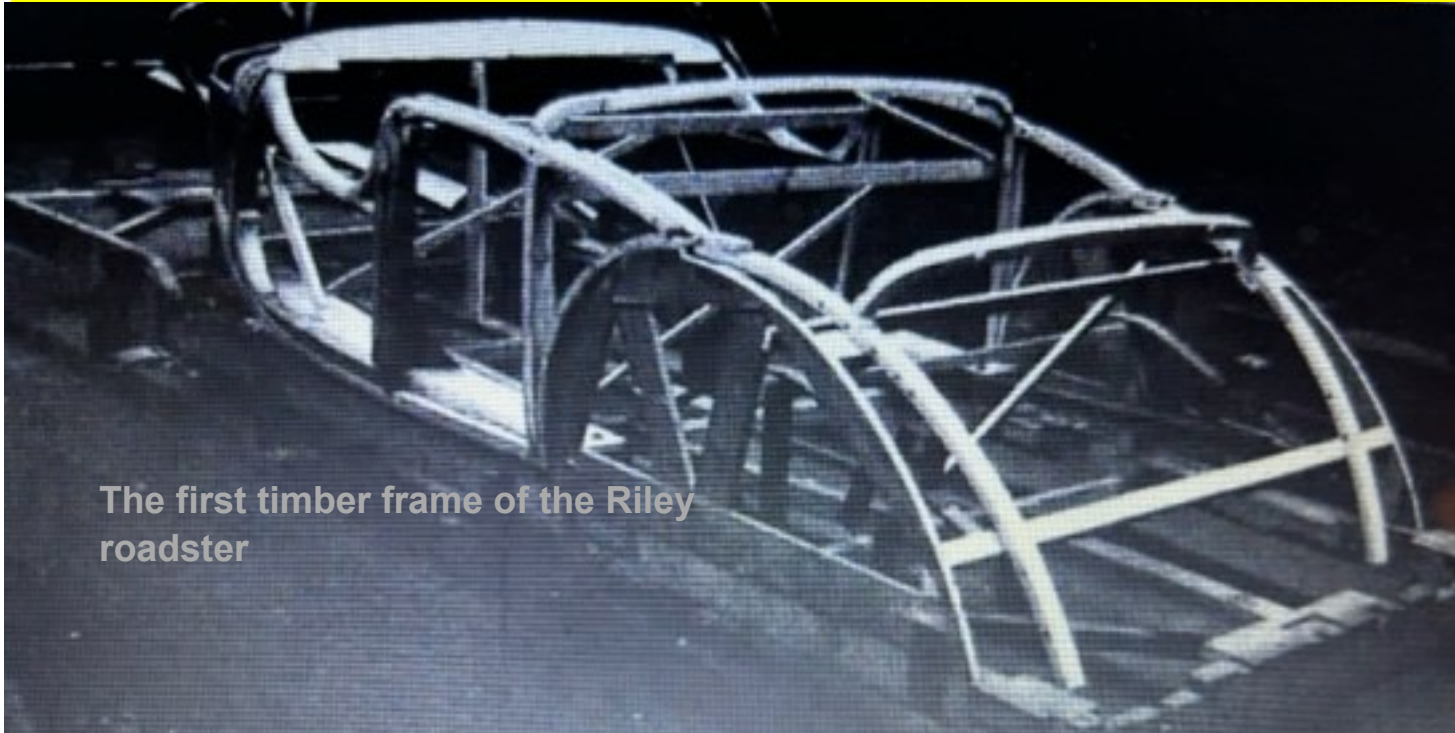
Framing the RMC rear end

The first timber frame of the Riley roadster

The imagination of the artisans in the Riley experimental body shop was amazing. In December 1947 a photograph was taken of the first timber frame. There is hardly a single straight edge on any timber component. No glue was used except perhaps the rear wheel arch was laminated to make the shape. Mild steel screws were used to fix the components together. This explains in part why little of the original timbers remained intact for enthusiasts to

As is my habit the rear end was attended to first. The side pieces under the main rib that attaches to the steel behind the seat was made first. The timber used was seasoned flooded gum because of its resistance to rot. The shapes were cut

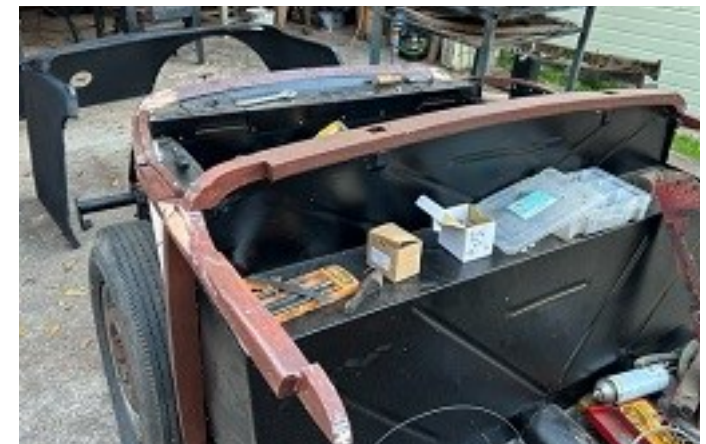
Below: The rib and side pieces trial fitted.

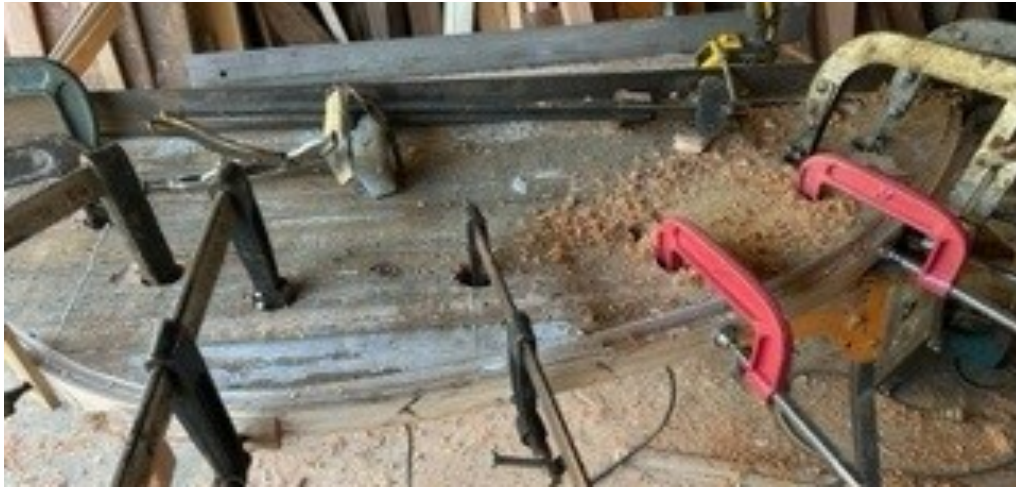
Above: Wheel arch template with strips of thin Hickory, glued and fixed into place with 'G' clamps.

To make the wheel arch the timber species, Hickory was used. Hickory is the timber favoured for making gardening and workshop tool handles in the USA. It is as tough as nails but when cut in thin slices it bends easily and with a marine epoxy glue will outlast the current custodians despite their youth. A former was made in the shape of the wheel arches and strips of hickory were laid over the former and each strip was glued to the one below it and fixed into position with clamps. Interestingly, the glue purchased was a marine glue. It prefers to adhere to a course surface (80 grit sand paper) and after the timber is glued

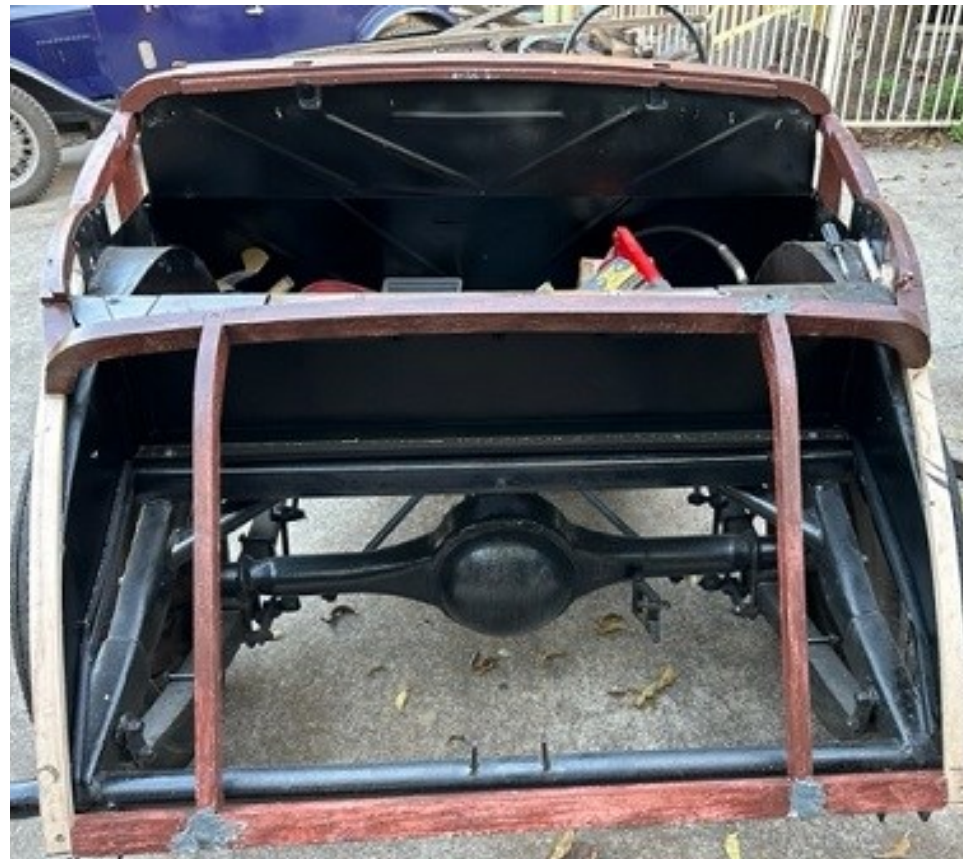
Below: Rear timbers trial fitted

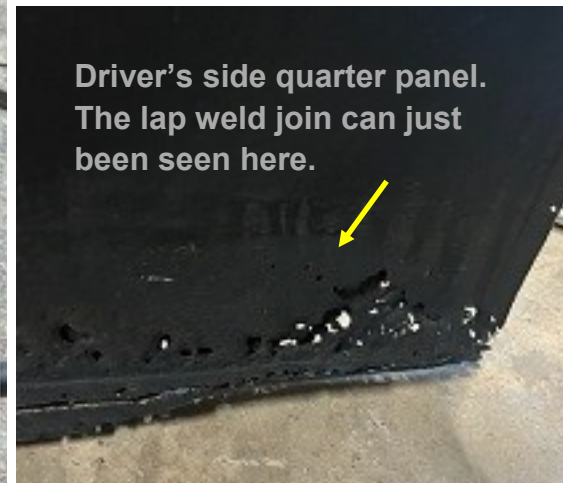
Driver's side quarter panel. The lap weld joint can just be seen here.

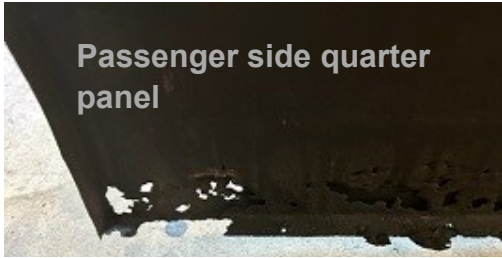
Passenger side quarter panel

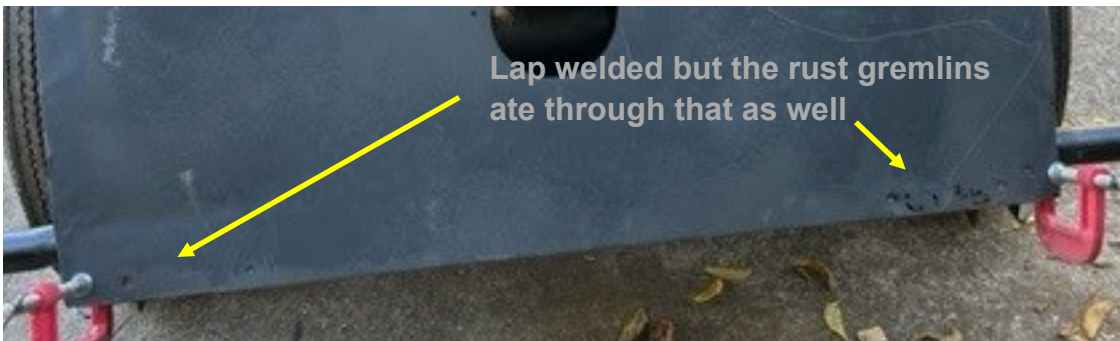
Below: The rear of the tub

Lap welded but the rust gremlins ate through that as well

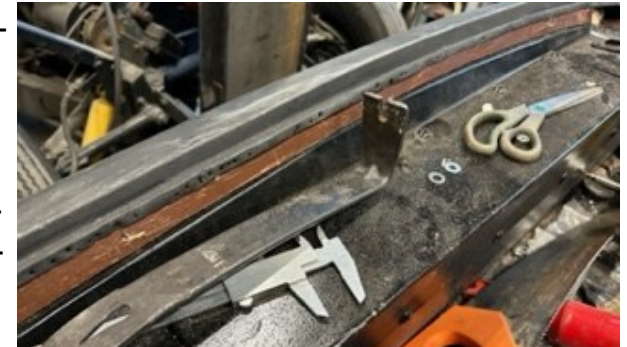
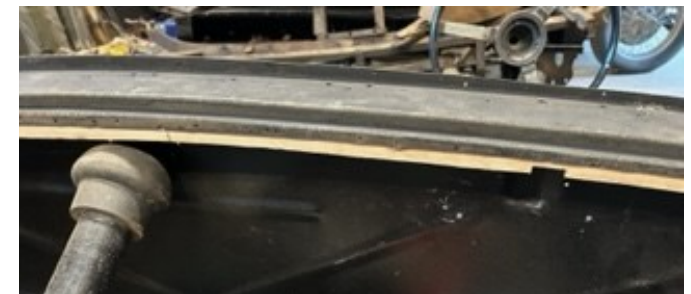
Above : rear of boot and Below: Rib in front of the boot

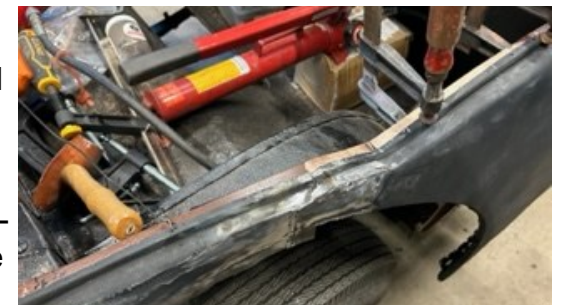
Below: Driver's side of boot

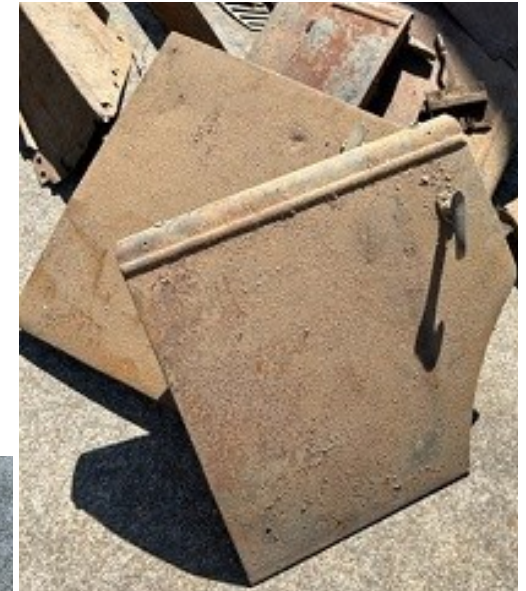
Above: The doors and below the tub

and doors and the panels were de-nailed.

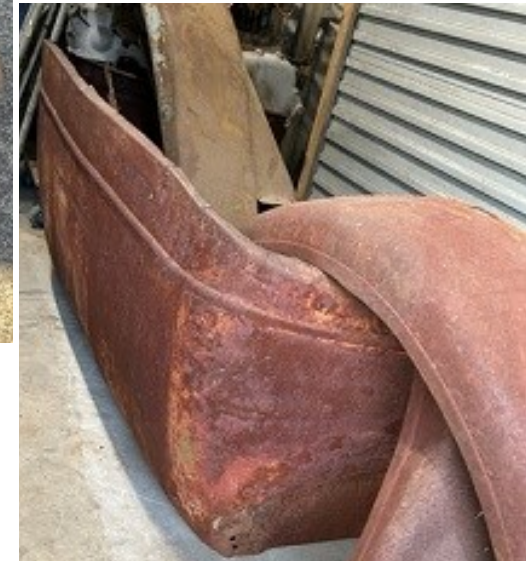
Above: The mudguards

When the parts were brought home, what was left of the timber frame was removed from the tub
