# Riley Restorer

**A magazine for Riley restoration enthusiasts  
in Australia February 2023**

## Henry's new lease of life

### *Getting the details right -The 1947 RMB*

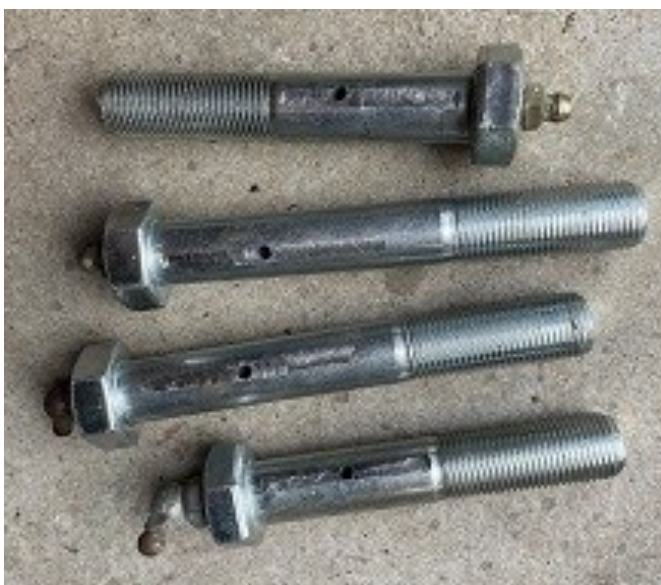
**Above: The shackle pins are high tensile steel and each was purchased of a length to fit the various spring hanger requirements.**

There are no Riley shops selling aftermarket shackle pins for SVs so UNF bolts of two sizes were purchased. They were drilled through the bolt head end using a 1/8<sup>th</sup> drill bit, then the top 3/8<sup>th</sup> inch was enlarged with a 3/16<sup>th</sup> drill bit, threaded and grease nipples screwed into the ends. The shanks were placed in a mill and flats machined and a hole was drilled to allow the grease to flow along the flat to lubricate the bronze bushes.

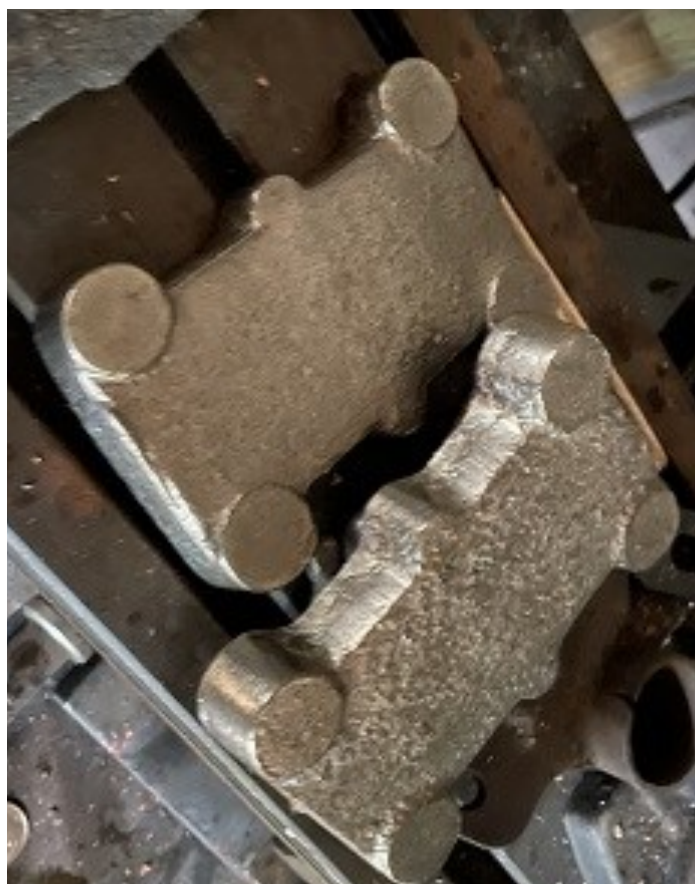
**Above: The plates copied from Paul's treasure trove.**

The end of the bolt that passes through the centre of the springs was cut off and the nut on the end of the bolt fitted into the cavity on the front axle. Pictures of Paul Bae's SV show a plate that fits over the spring and bolts are passed through the openings in the plate to fix it to the axle. These did not exist on Henry, so a non-ferrous foundry was visited a month previously and some plates were copied from a spare owned by Paul Bae. By the time of assembly they had not been made so the 'U' bolts that were supplied with the Riley were used as a temporary fix.

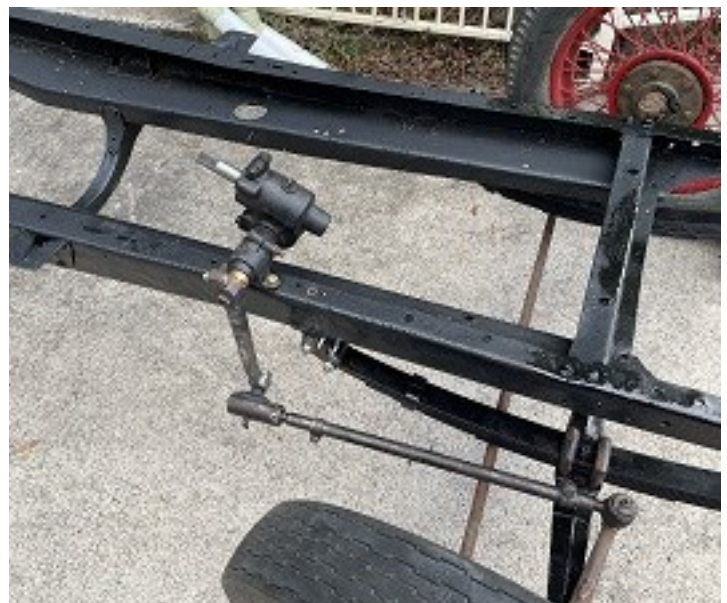
**Below: The Dodge steering box fitted with a post-war Riley pinion and drag link**

On the third day, the Dodge steering box was fitted to the chassis along with the drop arm that had been made a few weeks previously. The drag link used was from an RM steering system. The story about the Dodge box modification is in another magazine. But to explain its use a few comments are worth making. There are no intact Riley SV steering boxes in existence except those on a few Rileys that are in use, so a substitute needed to be found. Phil Evans told me about the Dodge box. It fitted into the Riley chassis bracket perfectly. It looked similar to the Riley box but it was made with cast iron rather than aluminium. It had the further advantage of having adjusting screws where the Riley box had none. The pinion was taken out of the Dodge box and an RM pinion was fitted in its place using the Dodge worm gear. Ken Lonie kindly machined the gear off the Riley pinion and the tube cavity was slightly enlarged to take the advance/retard and hand throttle tubes. Thrust bearings were sourced through the bearing shop in Zillmere.

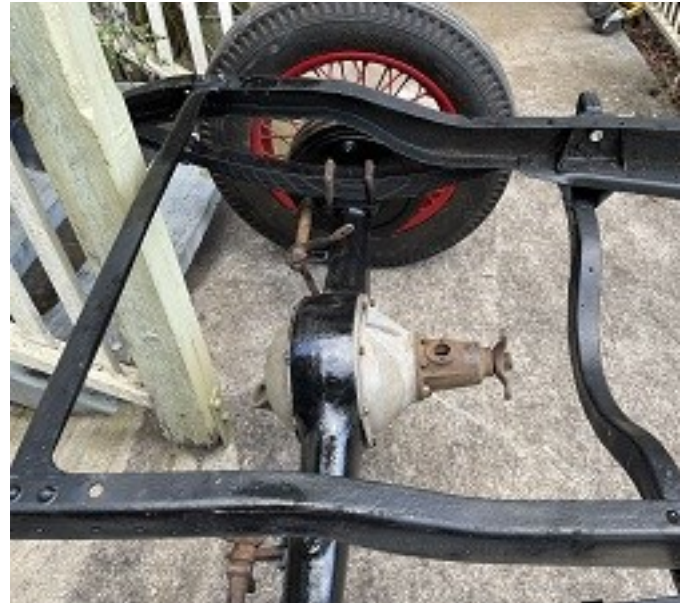
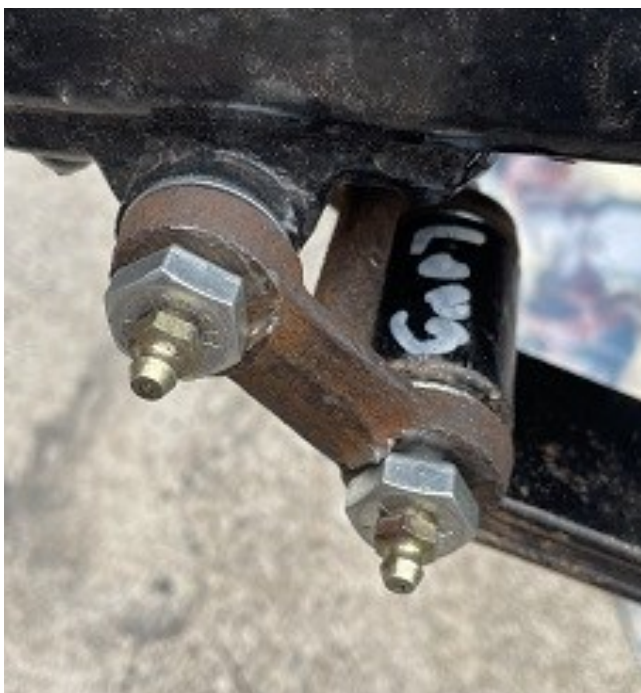
**Above: The shackles too far forward and below: The rear shackle position. They are about 2.30 O'clock—too close to 3 O'clock putting them at risk of swinging in the wrong direction.**

Co-incidentally Kurt Shultz visited during the week prior to Christmas. He was in Queensland to spend Christmas with the part of his family who migrated to the warmer climate. He brought diagrams of the chassis running gear and immediately we saw that the new suspension springs were all too short. How that could happen I do not know. The rear shackles instead of being at 1 O'clock or nearly vertical were at 10.30 O'clock. This meant that the differential was forward of the place where it should have been under the curve in the chassis. It also meant that there was a possibility of the shackles swinging in the wrong direction if the car hit a bump in the road.

The consequence for the rear axle was that it was too far forward.

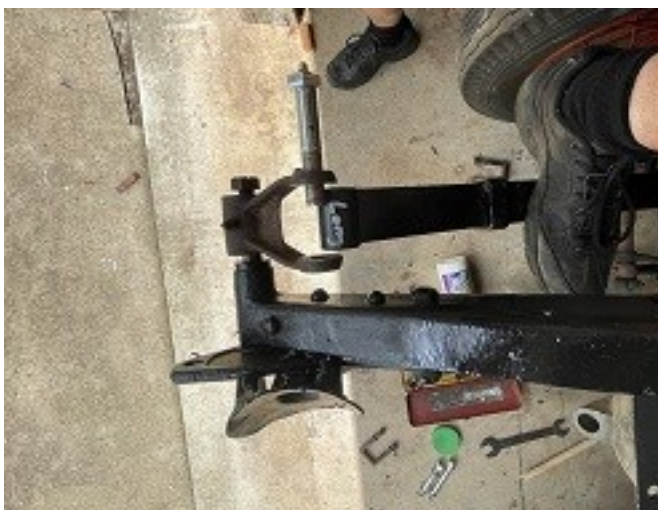
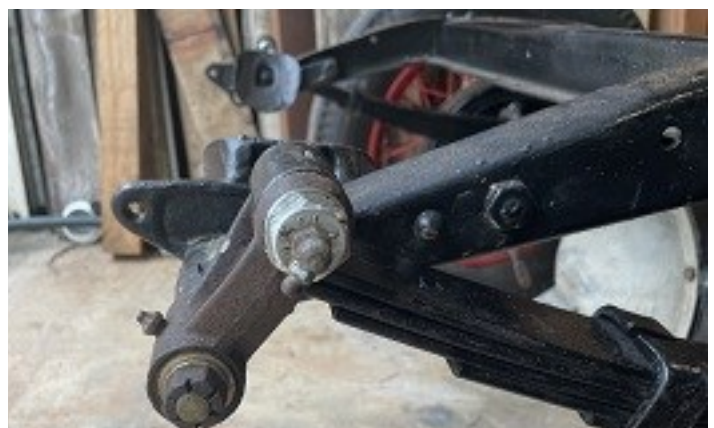
**Below: The rear springs re-fitted. The shackles sit at about 1 O'clock without the load of the body pressing them further back**

It is now the day before Australia day. The Australian flag is proudly displayed at the front of the house and *Spring Master's* have contacted me saying the spring assemblies have been rectified and are available for pick up. It is now late January and Henry may still be undergoing restoration in the year of his birthday. Close examination of each spring assembly showed that they were now flatter and two inches longer than they had been previously.

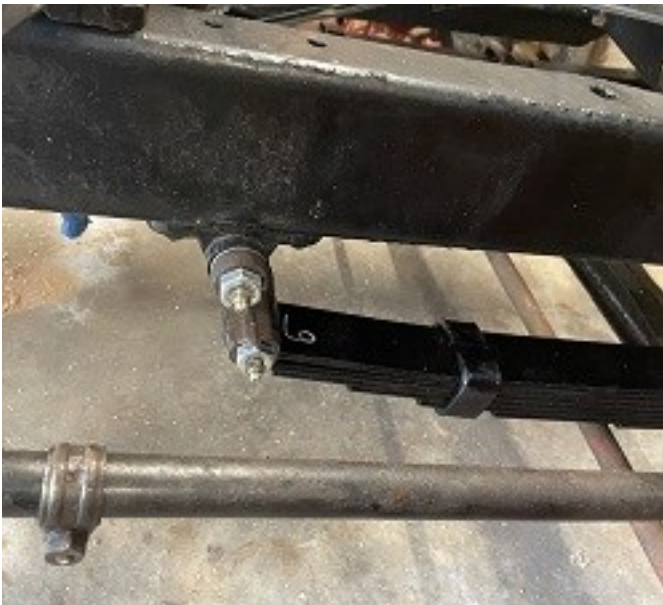
**Above: without the load of the body the front shackle seems to be in the correct position at 5. 30 o'clock.**

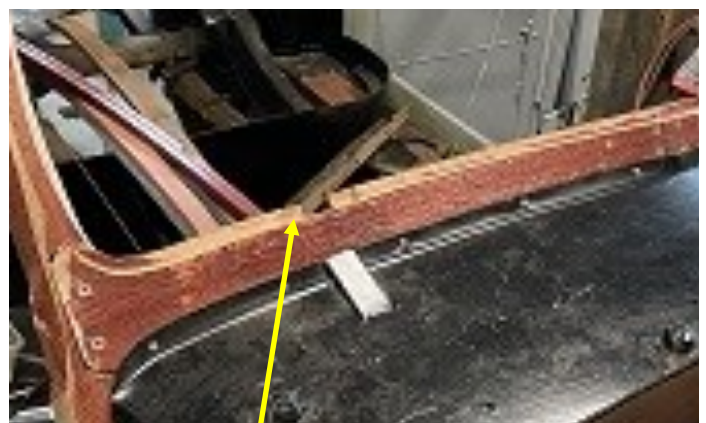
**Above: The window winding mechanism cut out is almost invisible.**

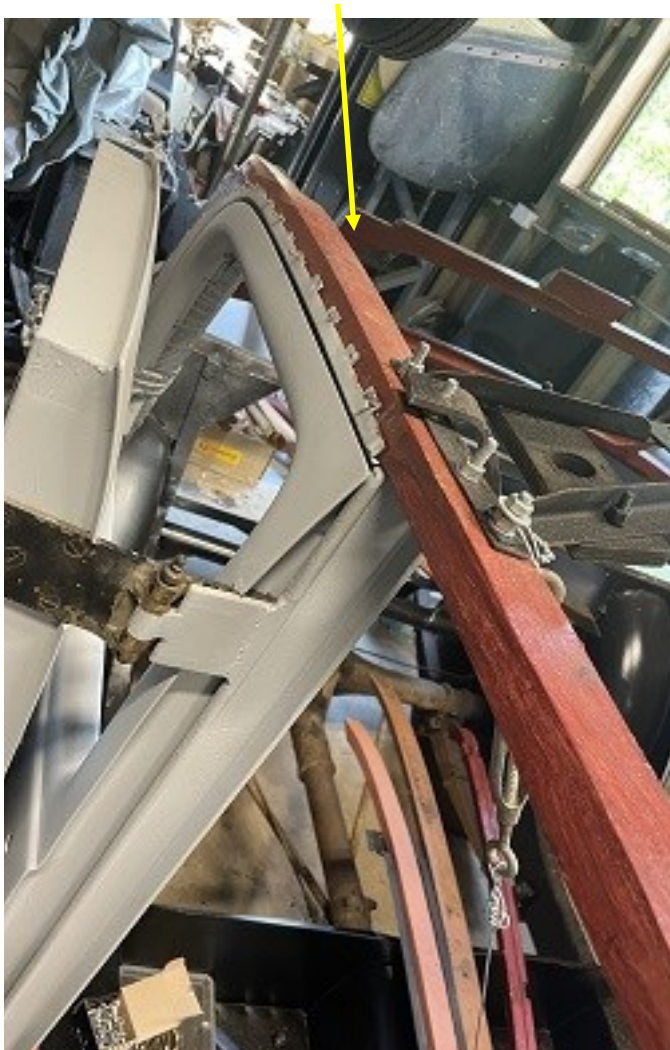
The 'A' pillars are angled slightly more in the middle to accommodate the windscreen surround and the tops are an 1/8<sup>th</sup> of an inch narrower to receive the top window rail.

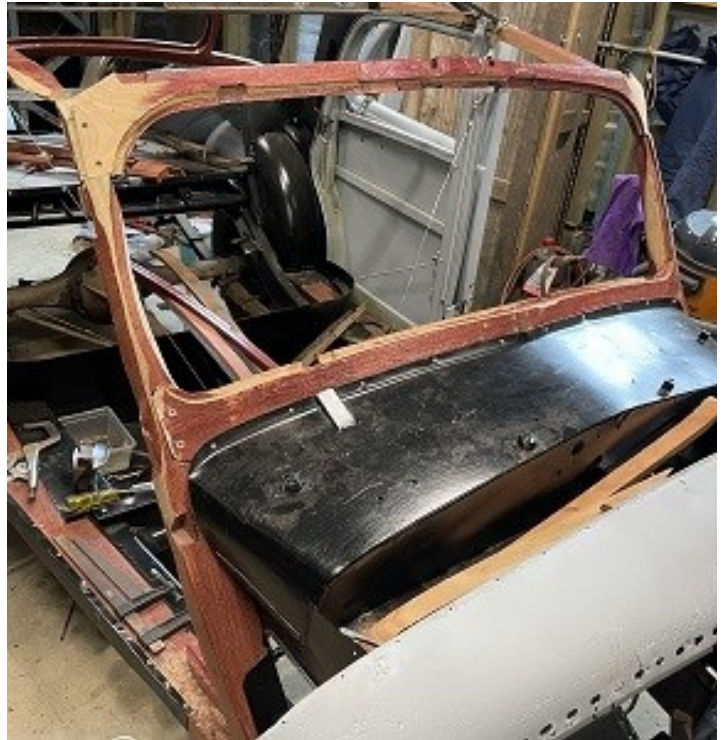
**Above:** You can see the curve at the side of the top windscreen rail.

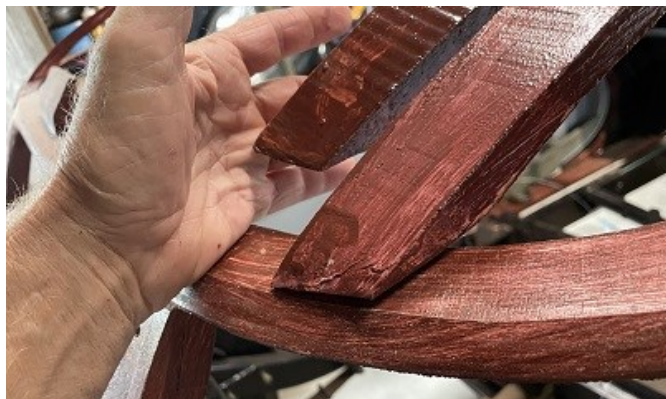
**Above: The roof rail on the left was made last year before knowing that the Riley was a '47 model.**

Today it was discovered that the roof rails are 1/2 an inch longer than on later RMs.

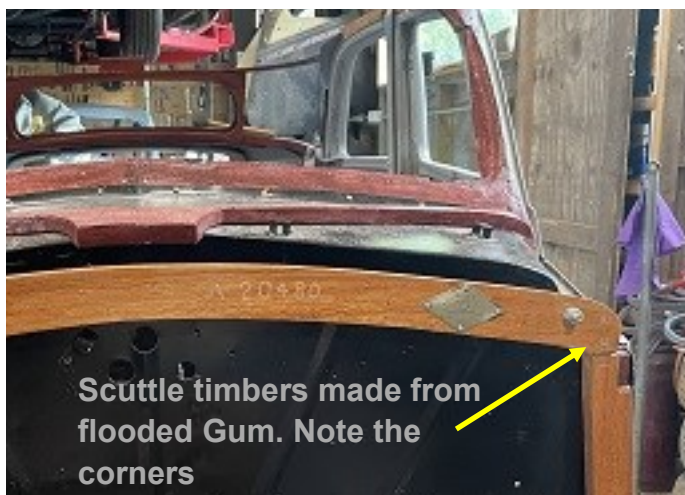
had been on and off the Riley several times as it was fitted into position. Strangely, feeler gauges are used to find the high spots on the front of the cant rail and the top and bottom windscreen rails. The bottom of the windscreen surround was already fitting well but there was a few high spots on the driver's side rail and cant rail. These were identified by pressing the surround against the timbers and running the feeler gauge between the timber and the steel skin. It is a slow process but it is better to inch towards the best fit rather than taking too much off and having a loose fit. Eventually the windscreen surround fitted into position snugly. The tell tale signs are the weld points on the quarter panels. They should line up exactly as they did prior to the strip down. The other tell tale point is the openings for the chrome piece that go between the bonnet and the front doors. These must correspond to the holes cut through the sides in the scuttle. Ultimately the only important thing is that the door jam fits up to the 'B' pillar and along the windscreen surround and the quarter panel to the knee block with a good gap when the front doors are closed.

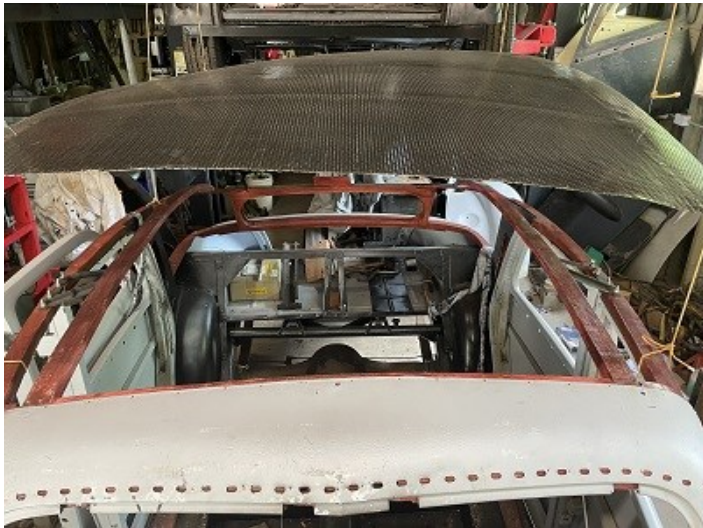
**Above: Roof metal hanging about**

In my garage there are four pullies permanently attached to the roof rafters. A chord is fitted and the end is tied back to the walls and when the roof steel is repaired and painted, it is lifted up from the floor using the chords and it hangs above head height until the Riley is ready for the roof steel to be fitted. After that nails and screws are employed to fix the door jams and roof to the body.

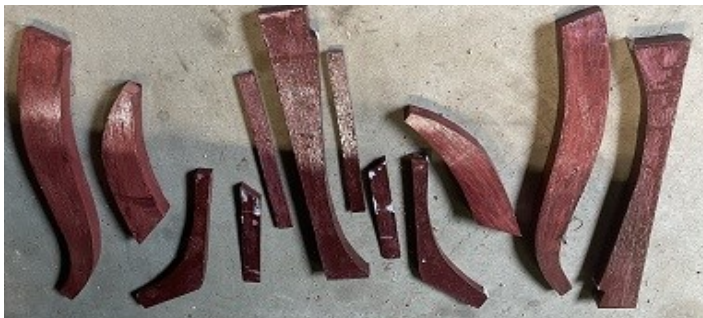
**Above: Interior timbers**

There are also a number of screws that attach the interior timbers and the 'A' pillars to the 'K' panel.

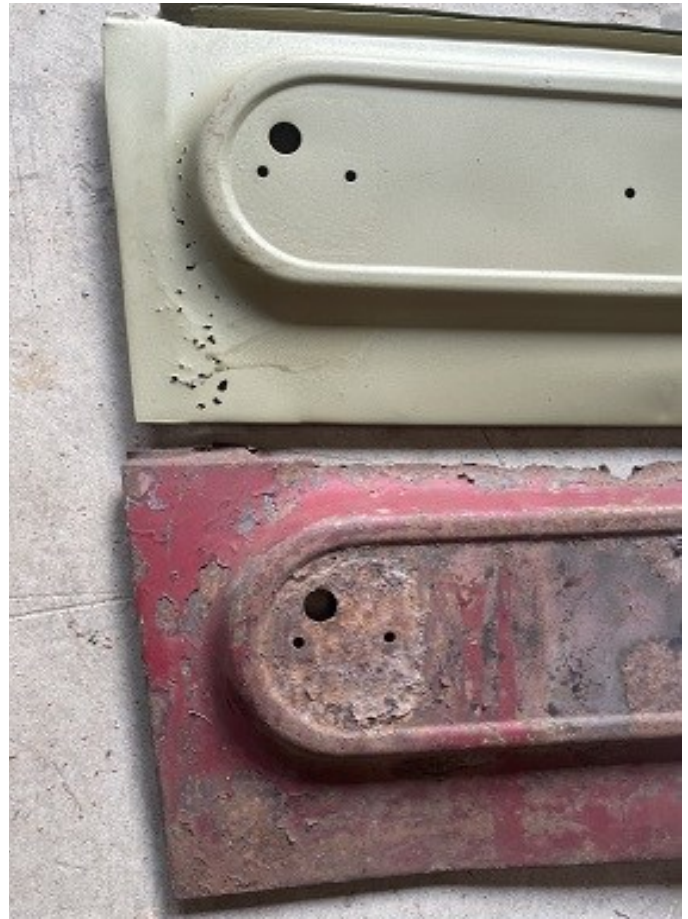
**Above: Spare wheel doors ready to be grafted together**

No spare wheel door came with this Riley so the best of the ones hanging on the garage wall was sandblasted to use for this Riley. Sadly the passenger side had numerous rust holes. Fortunately during a trip to the NSW second hand spare parts containers a door was scavenged that had rusted out on the driver's side. The two doors were cut along the same line and joined together to make one good door from the two rusted ones.

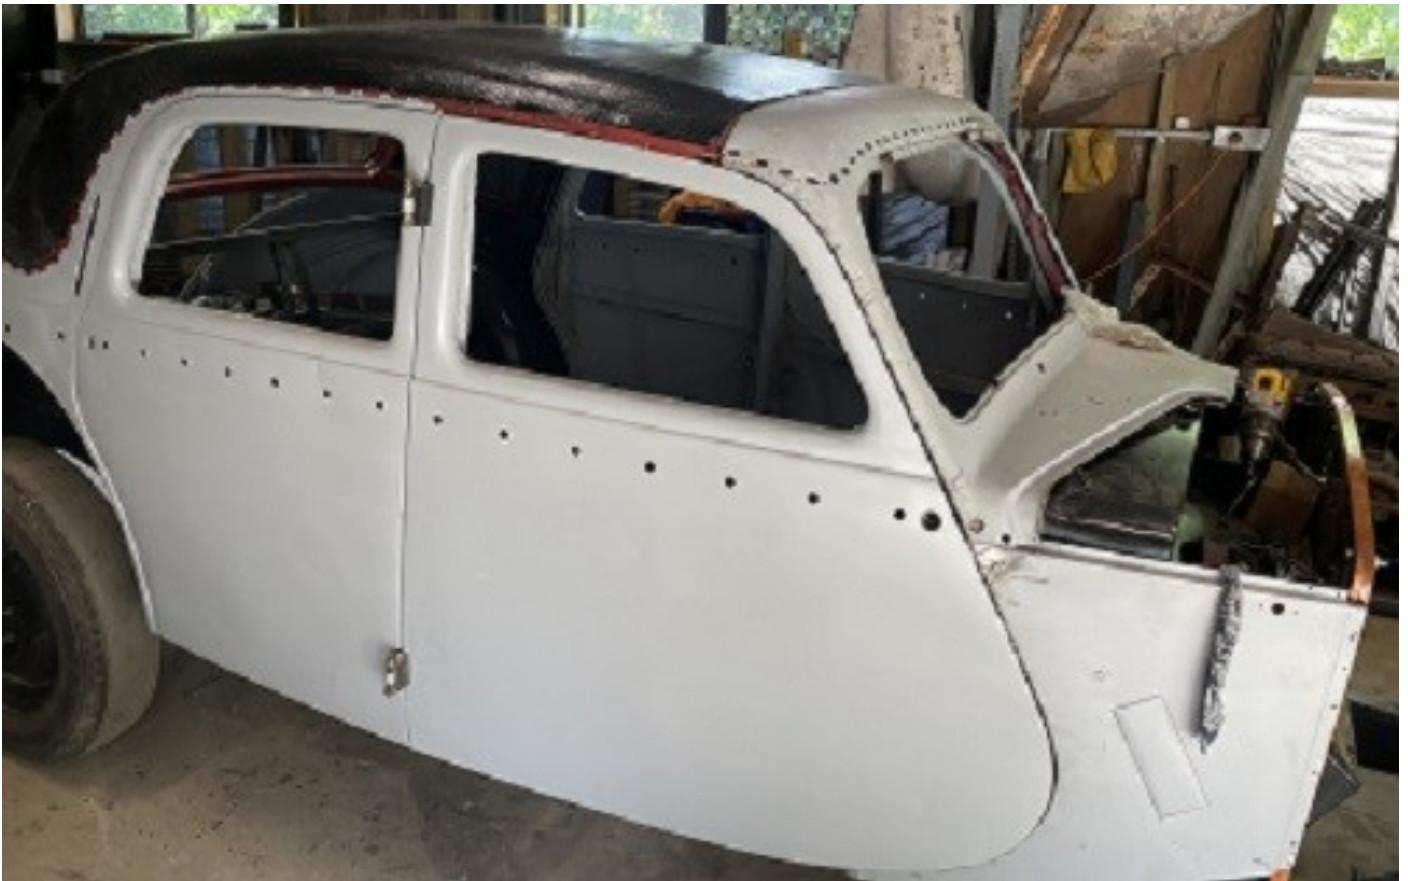
Above: The body completed. Notice the door gaps and the position of the quarter panels. They meet the front edge of the scuttle timbers—an excellent outcome.

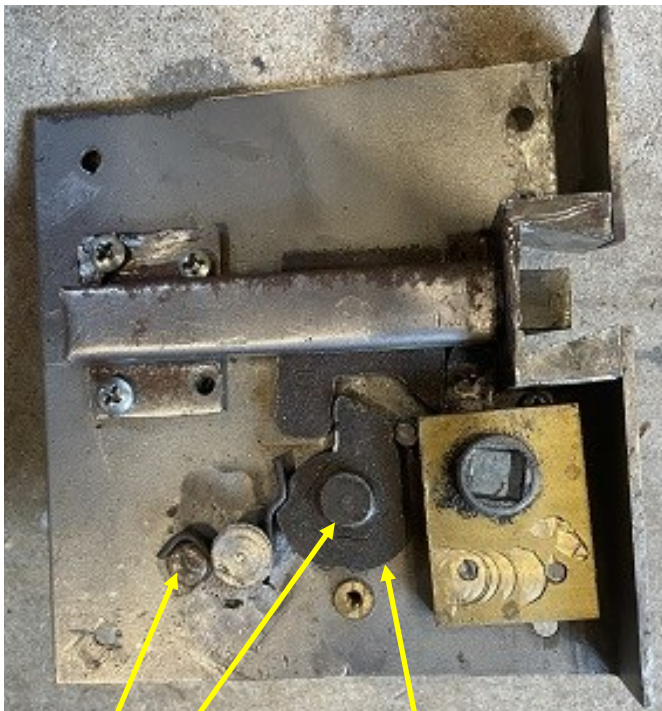
**Above: The locking mechanism.**

**The internal door handle fits onto the centre post. When turned it pushes the tongue back into the mechanism. The spring is a back door RM spring. When the interior door handle is turned backwards the centre piece locks into a space on the external door mechanism locking the door.**

This is how the locks were made: The parts of the lock that was sent from Ross' collection were looked at closely. The base plate was simply a heavy gauge sheet of steel that had a 90-degree bend. A friend had a bending machine that was capable of doing the deed so two pieces of steel plate that were cut to the correct dimensions were taken to his shed and for a miniscule amount of money the two plates were bent exactly where they were meant to be. After taking them home a vernier was used to measure the exact locations of each of the components. After double checking the component locations on the plates, they were marked with a scribe. The tongue was made from a square bar. One end was made round in a lathe to fit a spring onto it and the other end was filed to make the locking tongue. At the time I did not have a folding machine or a mill so a pedestal drill was used with mill bits. That might explain why the cuts look a bit rough and the folding of the bolt tung casing not that professional looking. The bolt was put into a vice on the drill bed to cut out a slot for the locking mechanism. This was cut from 3 mm steel plate. The sleeve that the bolt fitted into was simply a piece of panel beating steel bent to shape and fitted onto the locking plate with .

round head 2BA bolts. A 2BA tap was used to make the threads in the plate.

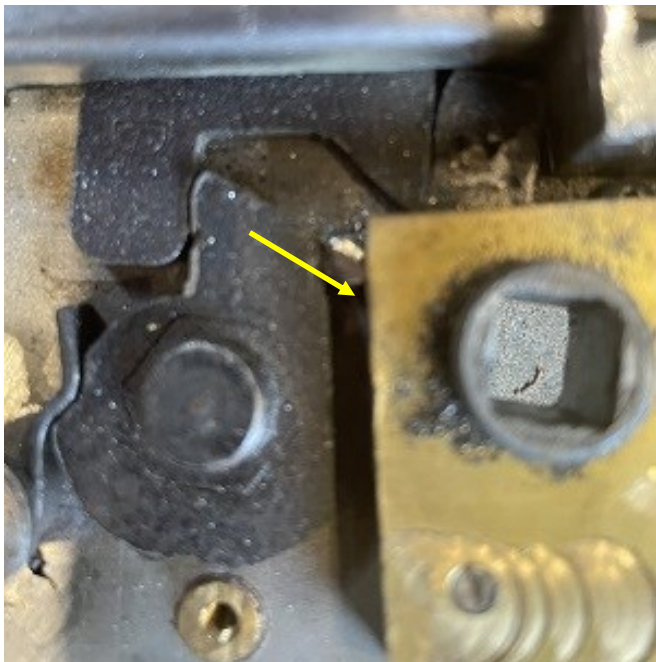
The internal door handle seat was scavenged from an RM rear door lock as was the spring. You can see from the picture that a mushroom like post was fitted to locate the spring and a peg was located on the lock plate to tension the spring. You can see that the spring fits into a slot in the door handle seat. The locking bolt is actuated by turning the internal handle causing the seat to press against the shape in the locking bolt. To lock the passenger side door the internal handle is simply turned down and its seat is locked into the external handle seat so the locking bolt is prevented from moving.

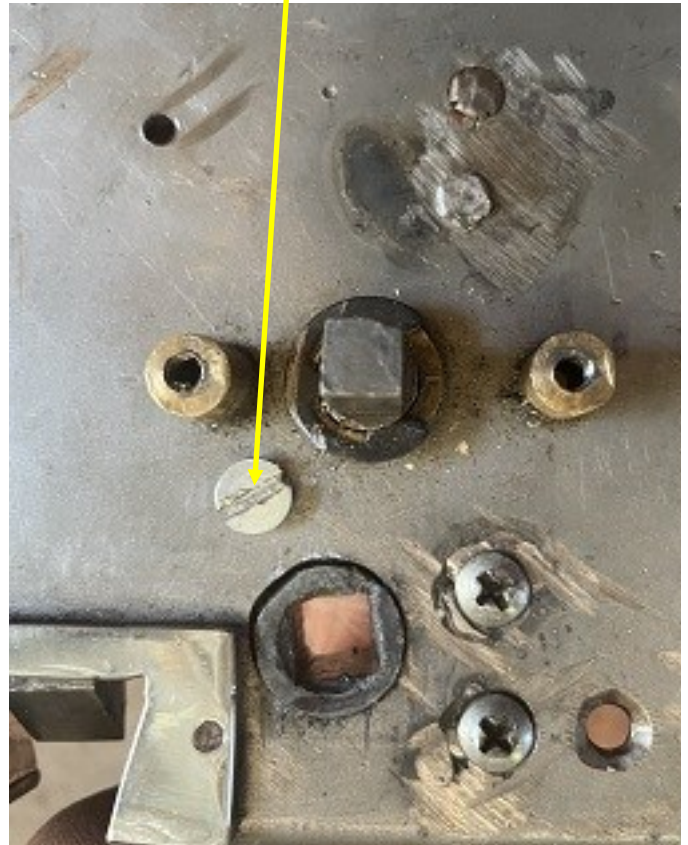
What about the external door locking mechanism? The key barrel operates a small bolt. I have not actually seen what was used originally in RMDs but the internal opening in the escutcheon was cut adjacent to the locking bolt using a mill and this was further developed by making a brass tube that fitted into the escutcheon with a cut out that extended the locking bolt cut out into the opening in the door. The escutcheon is fixed to the door with two screws and the brass extension on it fits into the door opening against the skin and this prevents it from rotating in the opening when the screws are removed. It is amazing how daughters can motivate fathers into doing stuff that otherwise would never get done.

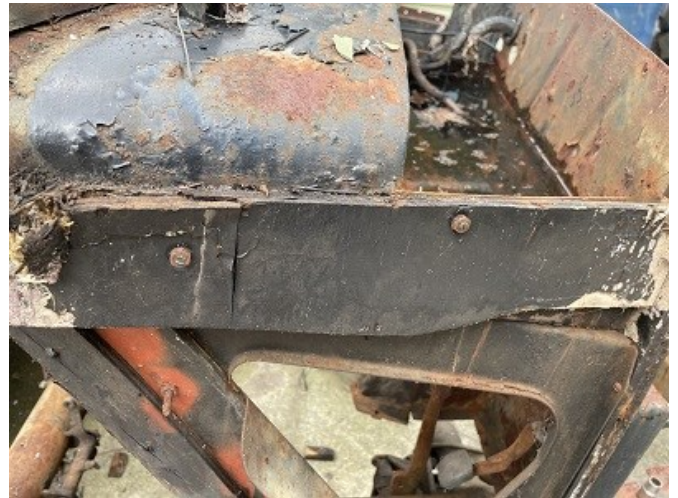
Riley's structural integrity relied entirely on the panels.

But then the vinyl roof cover was removed and you could see that a lot of bog was used to smooth out the ripples and fill in rust patches. The door jam was taken off the driver's side and some very interesting discoveries were made. The timber frame that was used was five ply. Where thicker timbers were required the 5 ply was glued one piece to another and then cut to shape. It was clearly not marine ply or even good quality construction ply. It had delaminated some long time previously. The

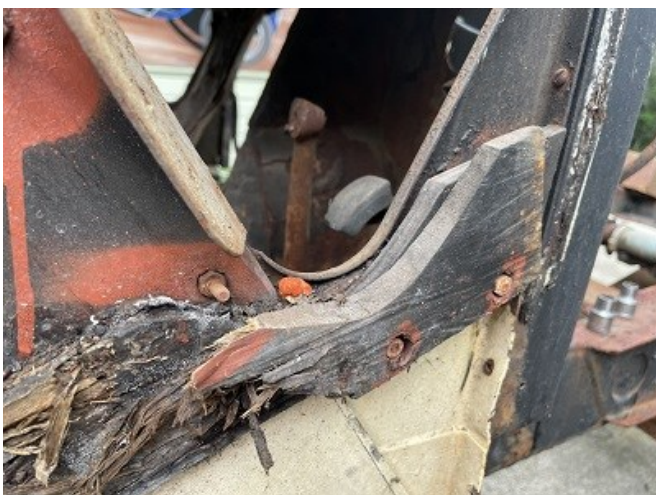
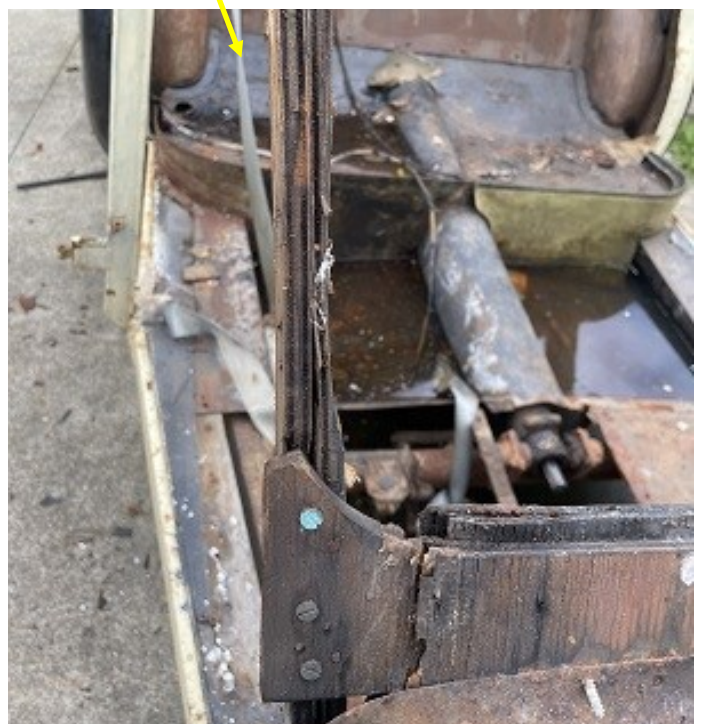
**Below: The 'A' pillar seems to be delaminating.**

But none of these things really mattered. the metal could be used to replace parts on other cars. But the fact that it was built using 5 ply was interesting. It also showed me that there was a certain risk involved in buying a Riley with the view to putting it back on the road without really looking at the smallest hints of something amiss. Perhaps the clearest hint on this or any Riley is at bottom of the 'A' pillars. If there is rot or there appears to be a replacement of the bottom bit of the timber it could mean a complete rebuild using a new timber frame.

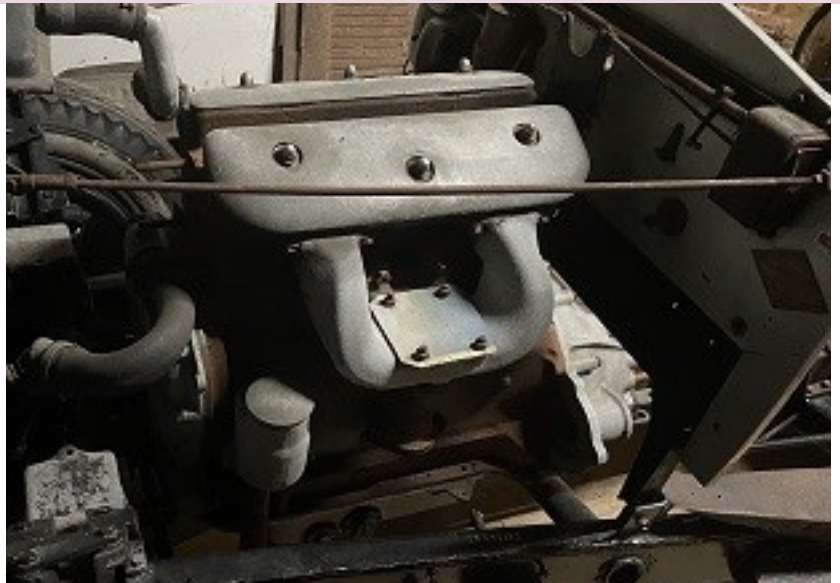
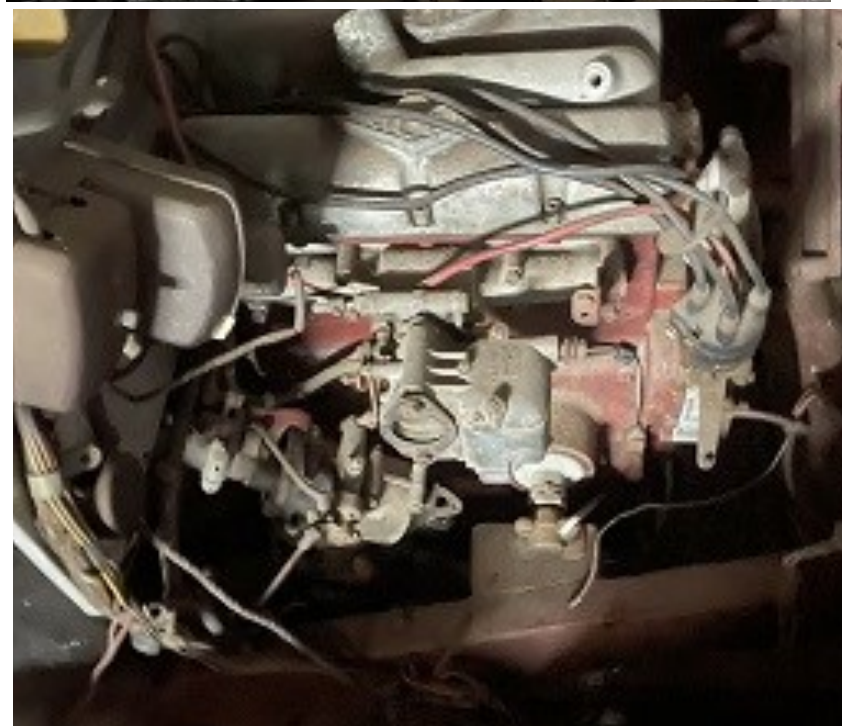
**Above right ; a Big 4 engine**

**And adjacent: a 12/4 engine**

RMA/12/4      Approx 160kg

15/6 engine    Approx 250kg

RMB engine    Approx 225kg
