# Riley Restorer

**A magazine for Riley restoration enthusiasts  
in Australia    December 2022**

## Silver Streak update (Riley V8) by Paul Bae

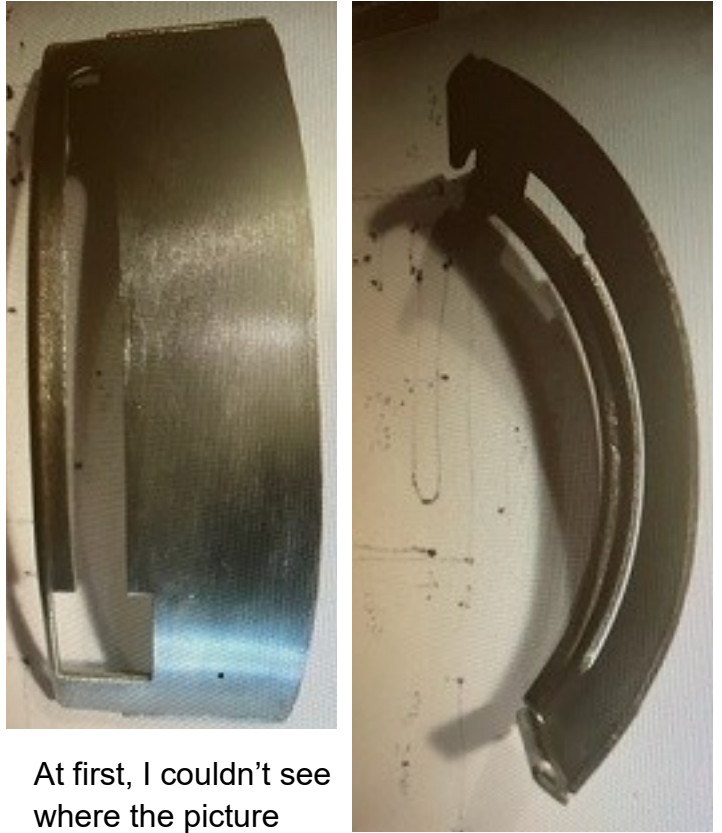
**Below: Pictures sent by Jim of the missing part.**

At first, I couldn't see where the picture sent by Jim was fitted into the assembly. So I waited for his telephone call to find out. Since Percy never past by a chance to revise mechanisms (not always for the better as this mechanism seems much better and less problematic than the post war mechanism) the mechanism in my Riley may not be the same as in his Falcon. If his part is not the same as the part in My Falcon, maybe another Riley enthusiast could lend Jim the bit to copy?

No need for another lender. Jim phoned back. The reason for not finding the part in the Big 4 was because it was not there. Some earlier enthusiast had taken it out, perhaps to fit it in another Riley. The part was in the 12/4 and after it was removed the part was sent to Jim for copying. The hidden value in the loan is that Jim said that he will make two copies and send the original and a copy back to me. A win win scenario.

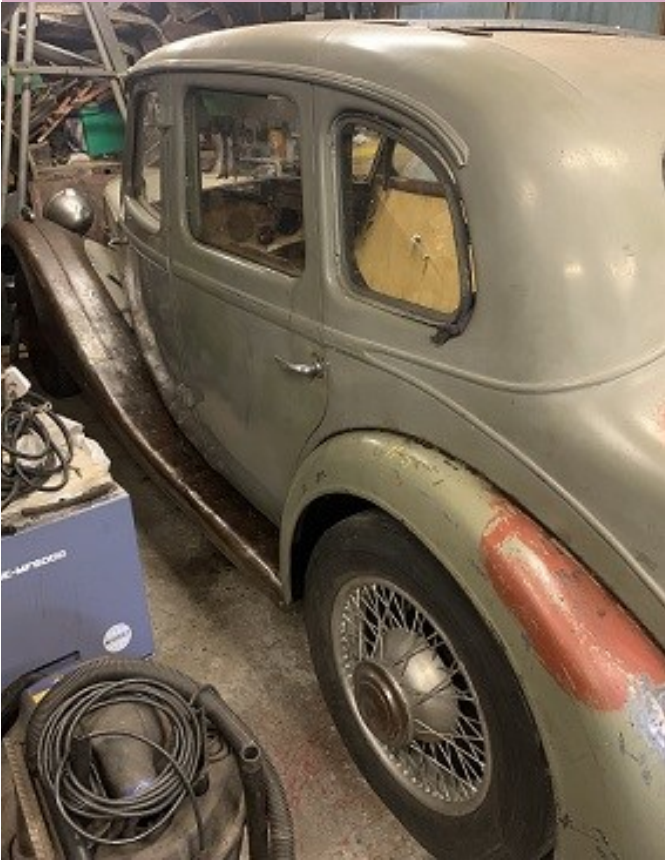
### **Above: A picture taken a few weeks ago of Silver Streak**

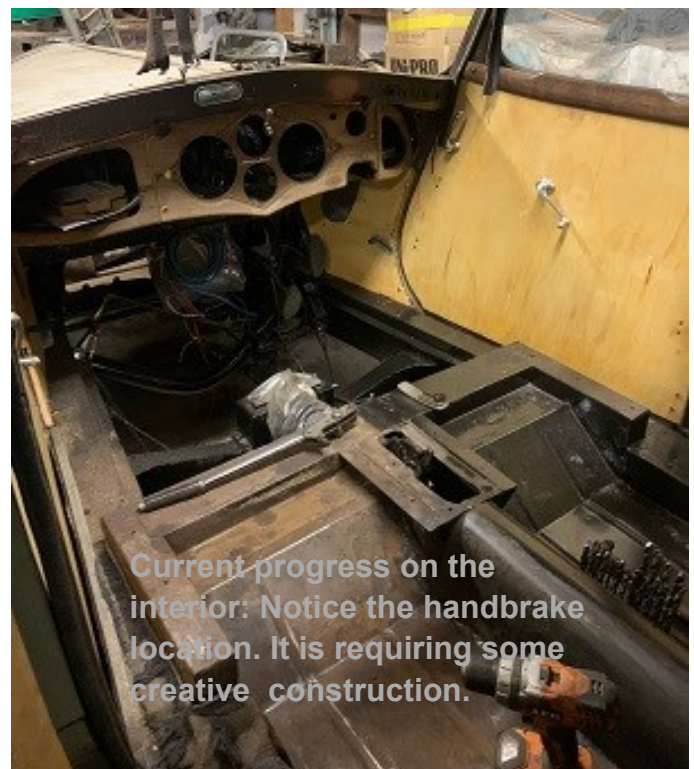
**Current progress on the interior: Notice the handbrake location. It is requiring some creative construction.**

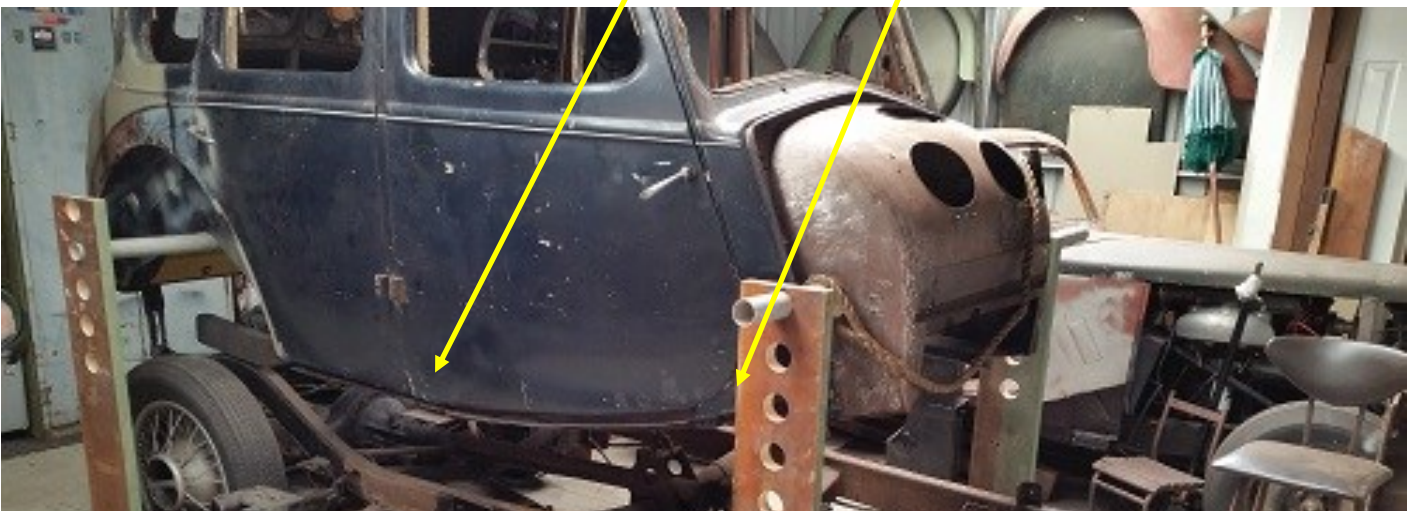
**Below: A picture of Cliff Goodman's Blue Streak project. On Paul Bae's project the bottom of the 'B' pillar was missing**

**and the connecting points between the body and the chassis was largely missing at the 'A' pillars.**

In September 2020 the major problem in completing the build was working out how the lower parts of the body fitted together as much of what was there originally had rotted away. The solution came with a shipment of parts from South Africa. Amongst the many parts was a complete Adelphi body. In December 2021 the container arrived at Port Adelaide Warf and Phil Evans steam cleaned the parts before they were inspected by authorities for contaminants and then he had the container moved to his country retreat on the Fleureo Peninsular. The editor of the *Riley Restorer* became involved at this point. It started perhaps three years previously when he was asked if he would transport all of the Blue streak parts to Sydney. The best of the parts would remain there and what was left over could be taken to Maleny. From the perspective of the Silver Streak project (pre-war Riley V8) all of the parts needed to complete the project would become available and there was sufficient Blue streak Adelphi (pre-war big 4) parts left over to complete the second project in Maleny. The deal agreed to was that the body in his garage

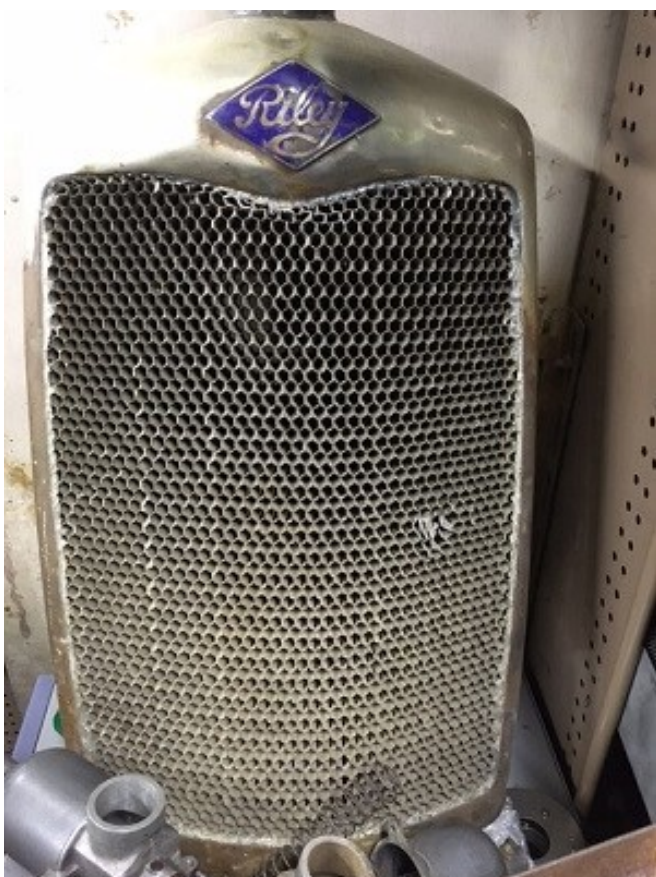
**Below: The Silver Streak radiator not when the picture was taken but now restored**

The work on the Silver streak had in the meantime continued with the restoration of the radiator. The radiator in these pre-war Adelphi's are similar (but different) to the post-war RMs in that the radiator is separate from the grill. The grill is bolted to the radiator and the radiator itself is mounted on rubber mounts. The construction is something between the honeycomb makeup of the Riley 9s and the RM squares. Sadly, with this particular radiator, the core and bottom tank had rotted out. Previously, holes in the bottom tank had been filled with silastic and this may have hastened the decline of the radiator as many silastics have acidic content. The vehicle may also have lived near to the sea. In the end the bottom tank, the radiator core and the mounts needed replacing. Fortunately, people in the Auto restoration business were able to put Paul into contact with a vintage radiator specialist and when it returned to Paul's garage it looked the same as if did when it was new, but built with modern materials and of modern construction. In the future it will also be possible to fit an electric fan to cool the radiator just as is the case in many RMs.

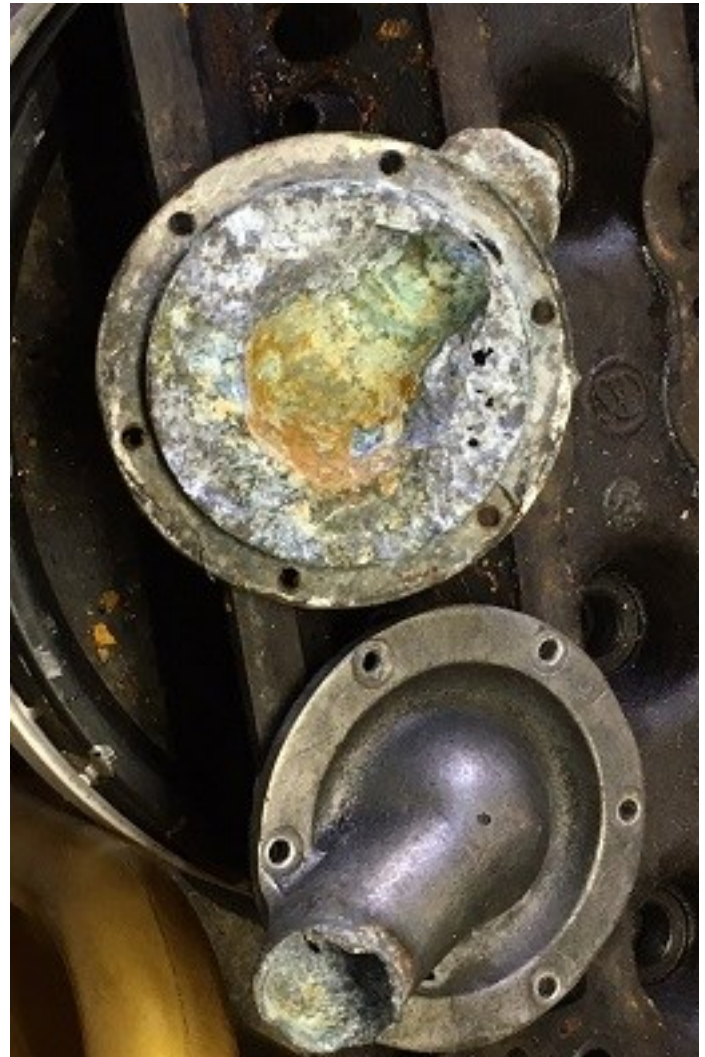
**Adjacent: the oil filter and above the water pumps.**

The oil pump was in reasonable order and BMW oil filters in series have been fitted into the oil filter canister.

There are two water pumps fitted to the Adelphi V 8s. They are driven from the exhaust cams and once again they look similar to the 12/4s, but their shape and internal arrangement are unique. A drive dog runs from the front of the exhaust cams into the water pumps. They are sealed from the engine oil with 3-inch diameter carbon rings. The impellers live inside the pumps and are driven by the cam shafts. There is a nut that fixes the mechanism together at the front of the pump with a copper washer to seal the water in the units. To disassemble them 3/16<sup>th</sup> of an inch holes were drilled into the impellers and a tool was made to hold the drive dog and via this method it was possible to disassemble the units. The inlet

opening for the water were both rotted out. The internal mechanism on one of them was rotted out. Both of the units had cracks, and both required Speedy seals to line the drive shaft. The seals in both pumps were worn to unusual sizes. To meet this challenge, Paul found a company that sold graphite, and this was machined to produce the two seals required. New aluminium tubes were welded to the units to receive the water hoses.

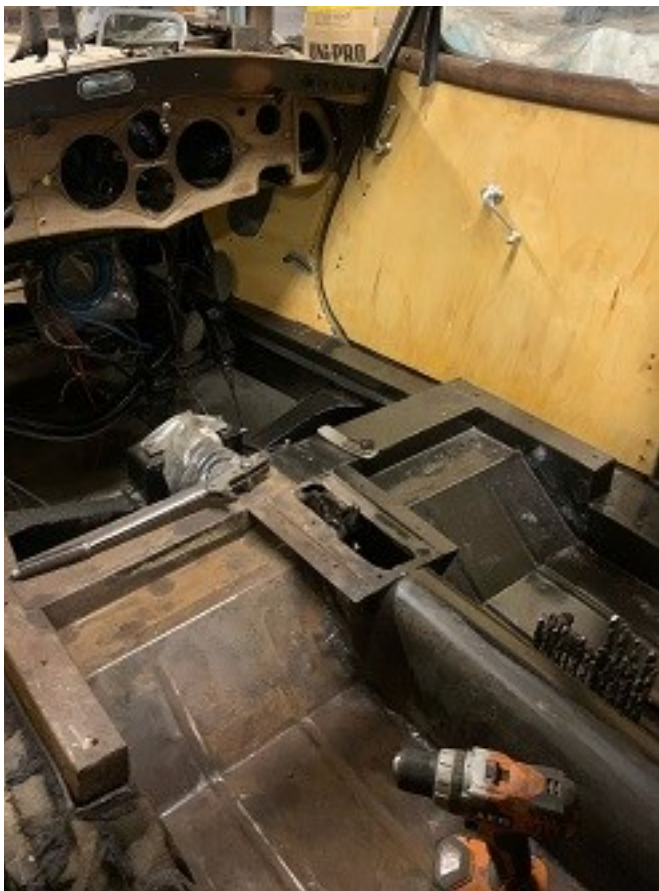
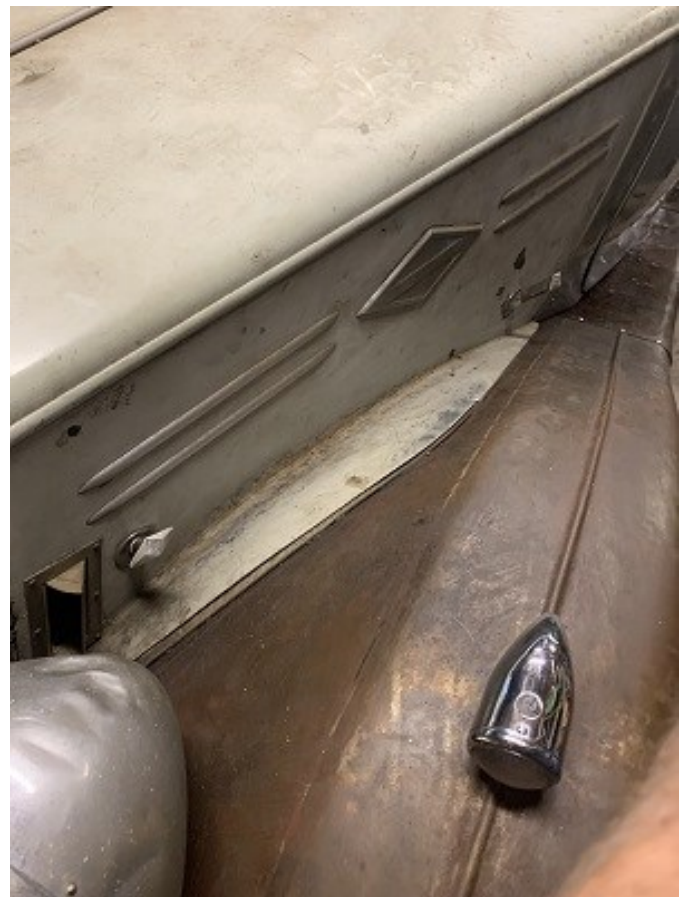
Various cracks in the aluminium skin have been identified and once the Riley is drivable it will go to a aluminium welding specialist.

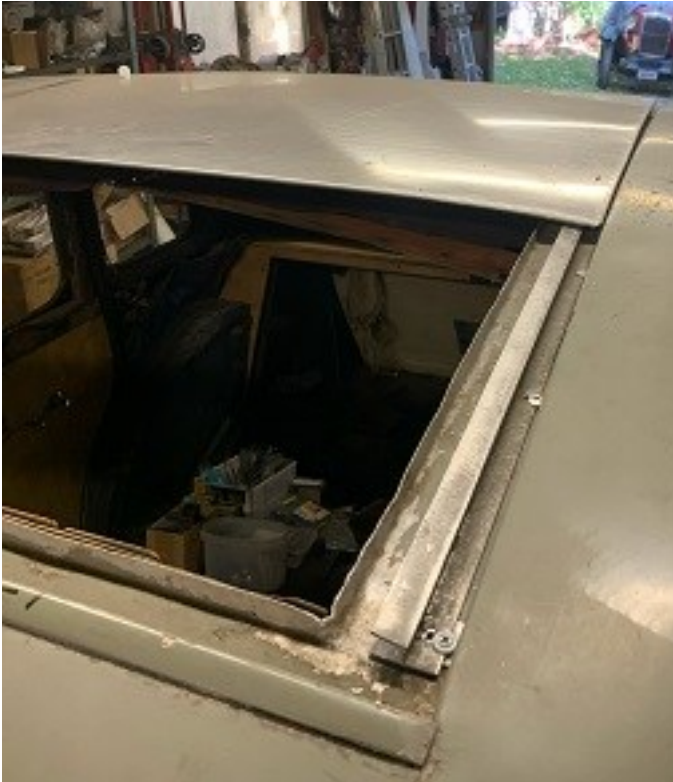
#### **Above : The sun roof with its sliders**

Much of the boot, the interior and the engine bay have been cleaned and painted. The sun door has been fitted and slides easily in its tracks. The boot door and the cockpit doors have been fitted and close nicely.

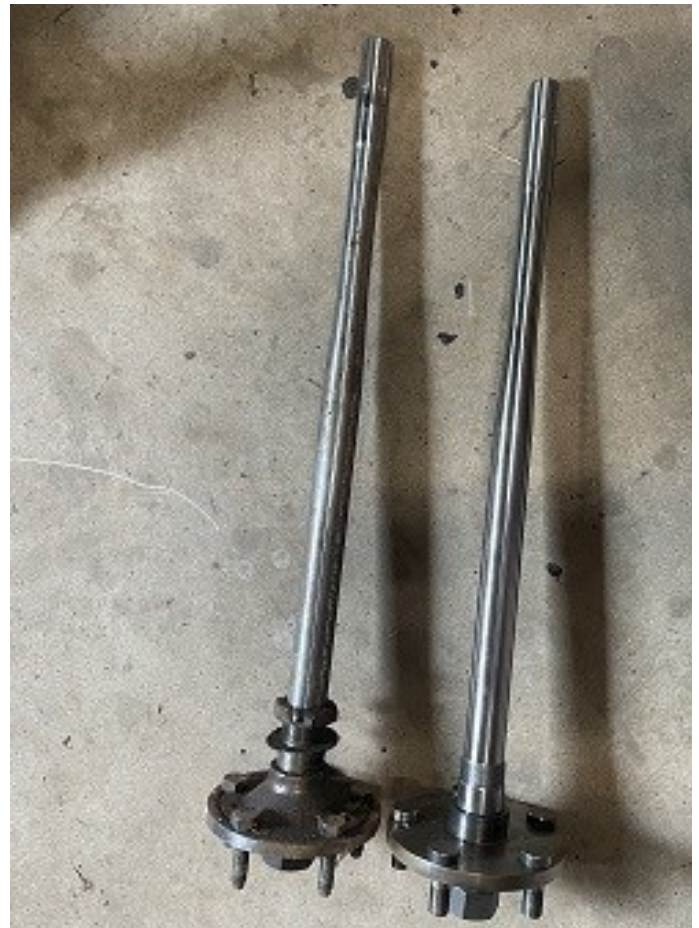
**Above: On the left is an RMB half shaft and on the right is an Adelphi half shaft.**

The original half shafts were in poor condition so a local company was engaged to make a second pair and since these were being made some others were made for Blue streak enthusiasts. The half shafts are basically the same as RMB half shafts but are an inch shorter while the studs are larger. These have already been installed and have made a snug fit.

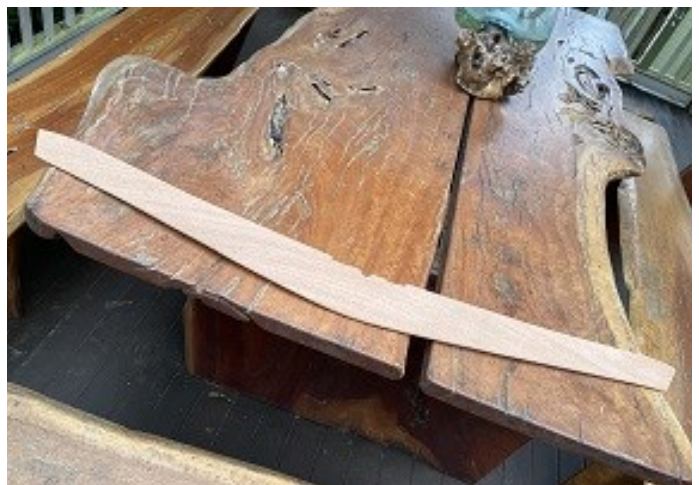
**Below: The Dash top completed and sitting on a Blue gum outdoor table**

Although the dash board was complete, the dash top piece was missing. A model was made up and it was reproduced in Northern Queensland Beech. It has a similar grain pattern to the existing English timber but the timber in the Riley had darkened over its years of service. The new part will need to sit in the sun for a few months to match the original timbers.

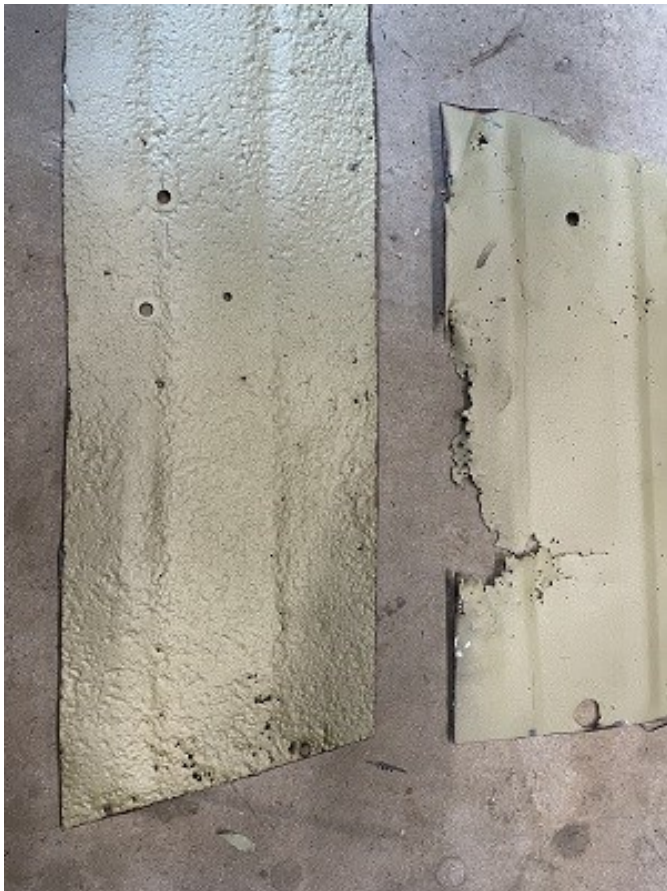
**Above: The battery box floor is on the right**

Both the battery box floor and the tool box floor

were rusted out. It is always easier to replace these sections when the scuttle is disassembled. The 'K' panel on the driver's side is bolted to the floor of the tool box so it is far easier to replace this when the scuttle is apart. The welding is also less visible if the floors are welded from underneath. The stress fractures around the top of the footwell are easier to weld when the scuttle is lying on a table. But the stress fractures under the floor of the tub are impossible to reach unless the tub is standing on its end. These were all welded above and below the tub floor and the brackets that were fitted in the factory to stiffen the support under the boot floor were welded from underneath.

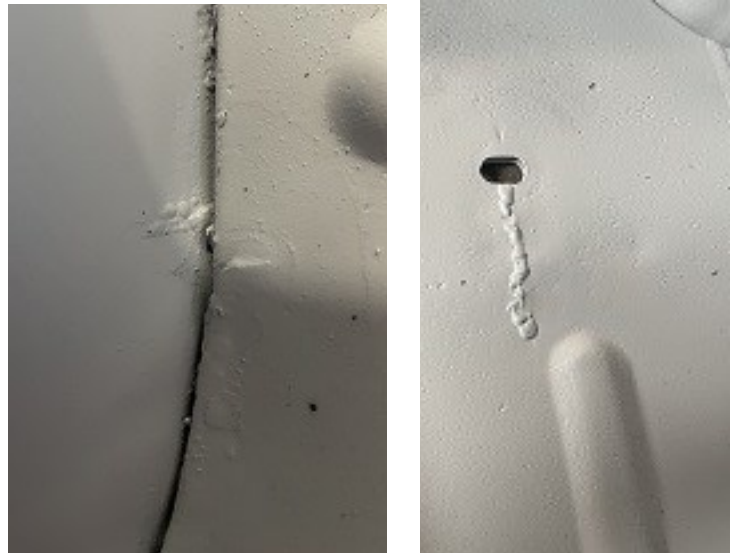
**Above: Tub floor welded from underneath as well as above**

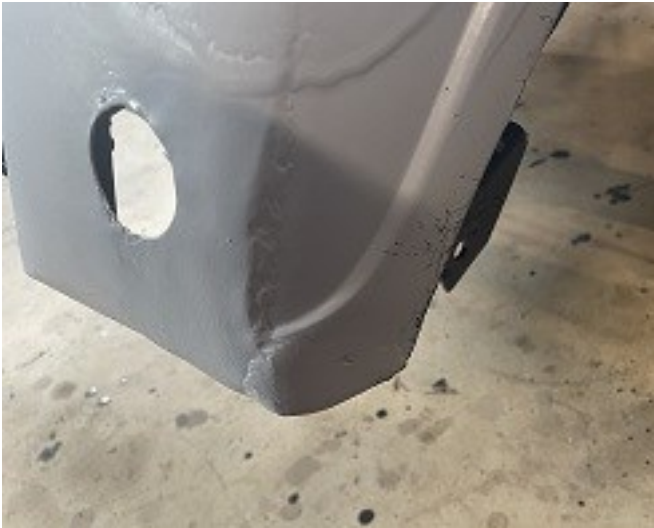
**Above: The drivers side tub skin and below the passenger side tub skin**

But what about the fractures in the external sides of the tub near to the bumper bar brackets? It could be imagined that if the Riley was in a rear end crash, the metal could be split but there is no evidence of a crash on both sides of the tub. In just the same way the sides were gathered together and the metal was stitched back together and then welded along the length of the split. Oxy-acetylene and soft wire were used to match the steel properties of the Riley body and the wire was used as a filler where there were drilled openings but the mystery remains, why are there splits at the rear bottom sides of the tub?

All of the splits and rusted out floor have now been welded. Afterwards the tub and the scuttle were painted to seal the metal against rust. Readers of the last *Riley Restorer* magazine will recall that the timbers were all remade, sealed and ready to be fitted. Over the next three weeks they will be fitted and the roof will go on to stiffen the construction ready for paint, roof vinyl and interior restoration. In the meantime the instruments are in Sydney for restoration and all of the gaskets for the engine have been purchased.

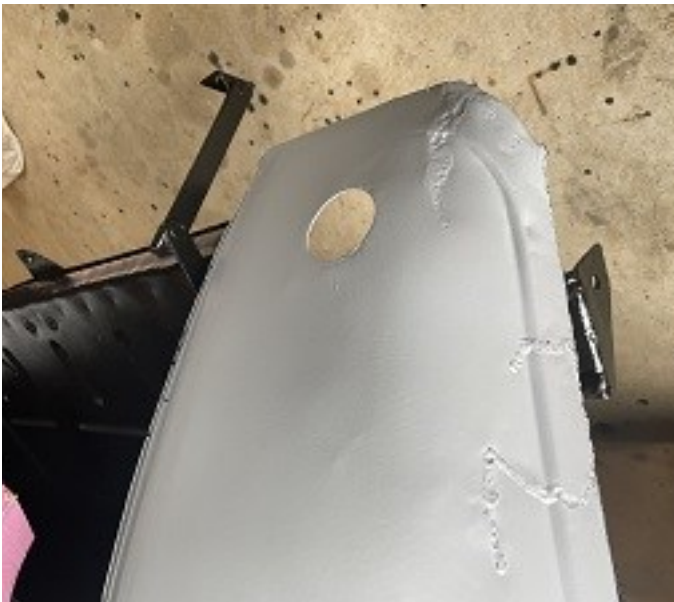
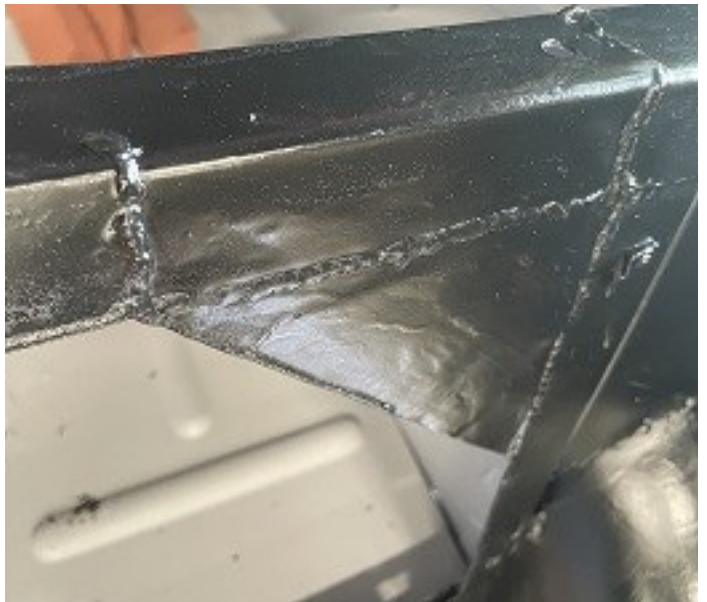
**Below: pictured are other commonly found splits behind the rear passenger seat**

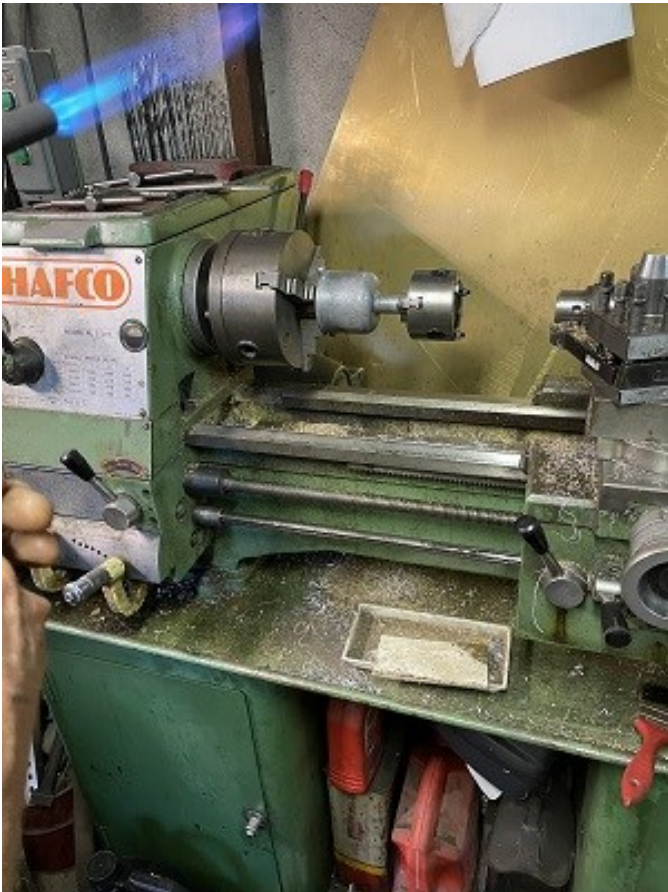
The lathe was spun at a low speed. Heat from a LPG torch was then applied to the body of the bell housing as it spun in the lathe, but not so much that it retained its grip on the piston. The small chuck was used to pull the bell housing from the piston. It came off surprisingly easily but it wasn't beginner's luck. It just wasn't that attached to the piston.

Surprisingly he used the same method as was used in my garage but with greater effect. So permit me to share the difference between his 100% success rate and my success rate (I am not putting a percentage rate on it). In the first instance he closed the teeth of a small 3 jawed chuck on the neck of the carburettor bell. The piston base was fitted into his lathe chuck and tightened to get a grip on it but not so hard that it damaged it.

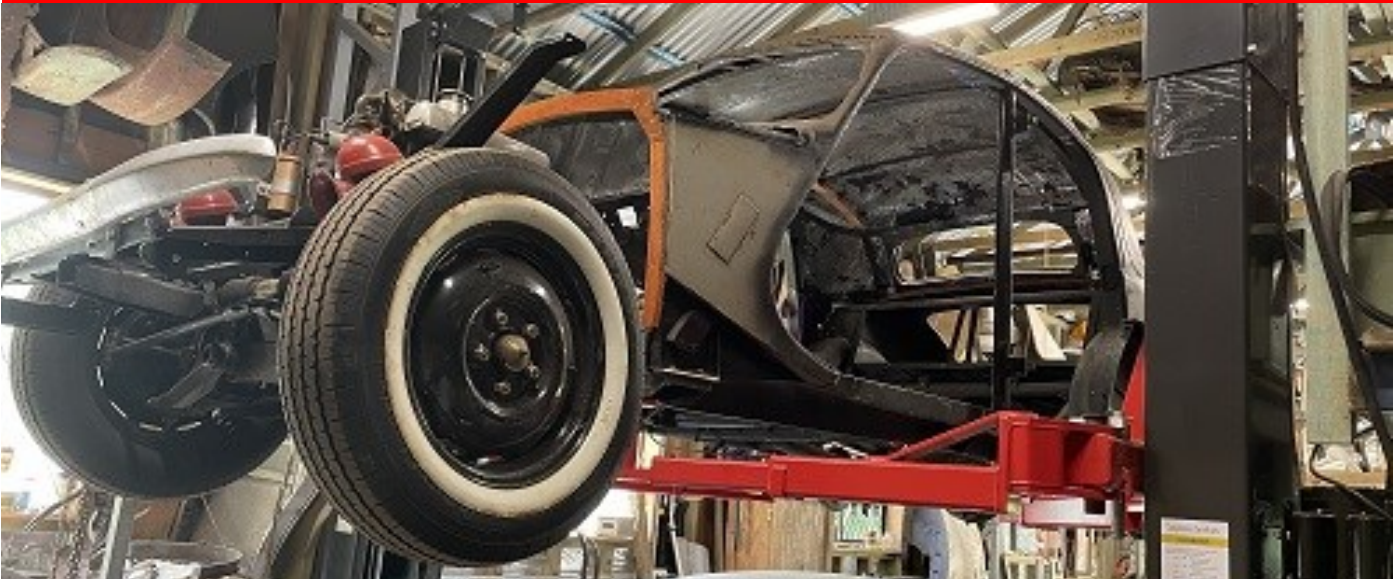
**Above: The progress on the RMA restoration is apparent. The engine runs, transmission is good. The timber frame completed and the body fitted**

A few years ago the Riley pictured visited my workshop. His custodians, a father and son team, asked if I could help out and make a timber frame and fit it as they did not have all of the tools necessary to do that part of the project. I was happy to give it a go so I took a few weeks off from my current project, the Riley 9 Mk 3, and made up the parts, framed the Riley and returned the result to the custodians. Well, life can get busy. COVID 19 was doing its thing and the primary custodian was busy in his employment as a medical specialist and his son returned to university. So, the Riley sat in the garage. Happily, for the custodians they lived only a few hundred meters from the sea and the family loved to swim and enjoy the seaside lifestyle. Unfortunately for the Riley, the salt air was not so good and with the distractions of life, painting didn't happen, and he began to return to the elements – dust to dust, ashes to ashes – that sort of thing. The primary custodian was then offered employment in Sydney and the garage needed to be emptied. Would I take the project on and complete it? Anyone who knows me is aware that I am passionate about getting Rileys onto the road and keeping them there, so I agreed to organise the finishing of the project. It was not that far off completion after all. The engine ran. The body was all together. The upholstery was in good condition.

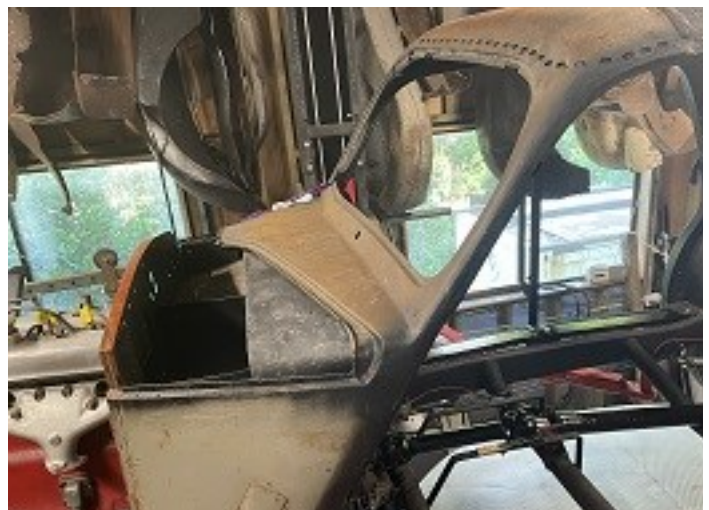
**Below: Surface rust on the window surround**

After picking the Riley up, a detailed study of what needed to be done was conducted. The father son team had done a fairly thorough job. The front and rear suspension was good. All of the shackle, trunnion and front suspension bushes were replaced with new ones. The chassis had been cleaned and painted. The engine had been attended to as well as the gearbox and both were in serviceable condition. But there were a number of subtle issues that needed to be addressed. There was surface rust not only on the body panels but also where the paint was a little thin. There were hidden areas where there was exposed steel and these were beginning to rust.

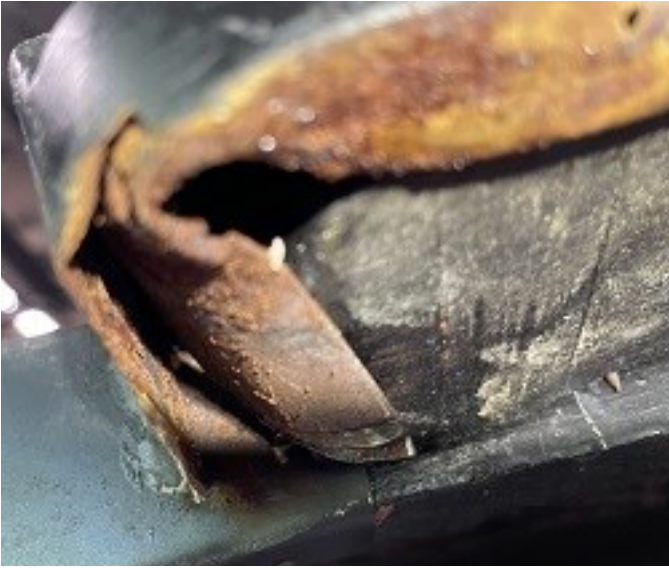
There were hidden areas where there was exposed steel and these were beginning to rust.

**Above: This is under the front passenger side quarter panel.**

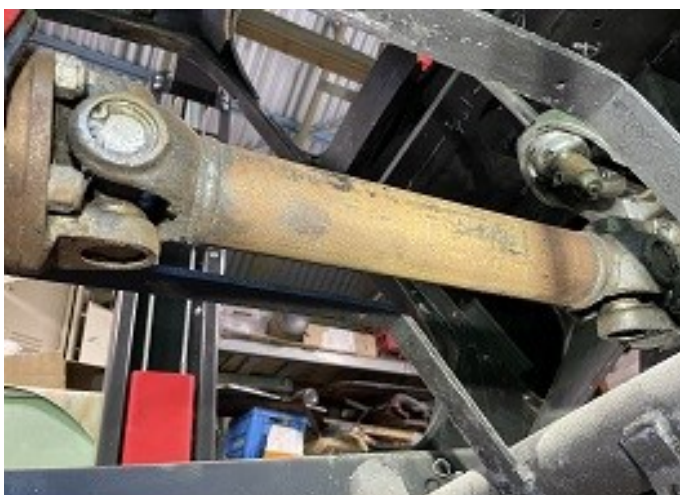
**Above: Surface rust on the drive shaft and wobbly universal joints.**

The paint used to cover the differential and rear wheel backing plates was petroleum sensitive and had already begun to deteriorate. The dust covers on the rear backing plates had not been replaced. The rear brake shoes were worn out. The differential seals were leaking. There were a few rust holes at the bottom of the tub adjacent to the rear doors. The universal joints looked alright but there was enough wear to fail a road worthy inspection.

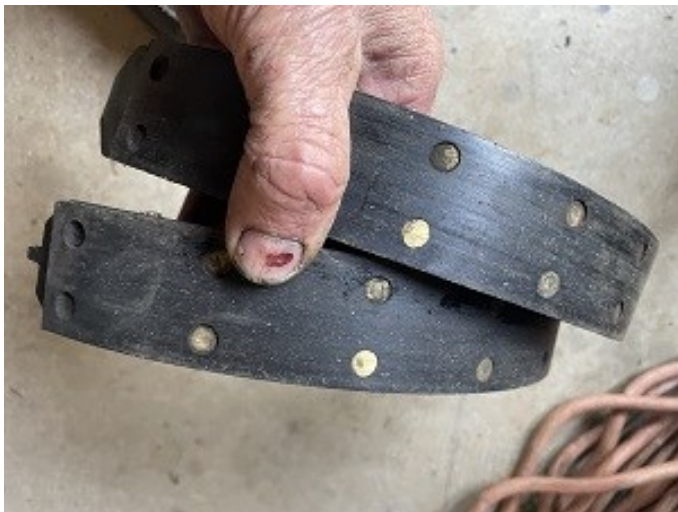
One of my favourite shops is Kawana Brake and clutch. There is a mature aged man there with an encyclopaedic memory of old brake parts and it is just as likely that he has them on the shelf. The brake shoes were taken there for the pads to be replaced. He did the job and

they are now waiting to be replaced on the Riley, but before that the diff seals need to be replaced

d. How do you know when to replace your brake shoes? When the copper rivets become

shiny.

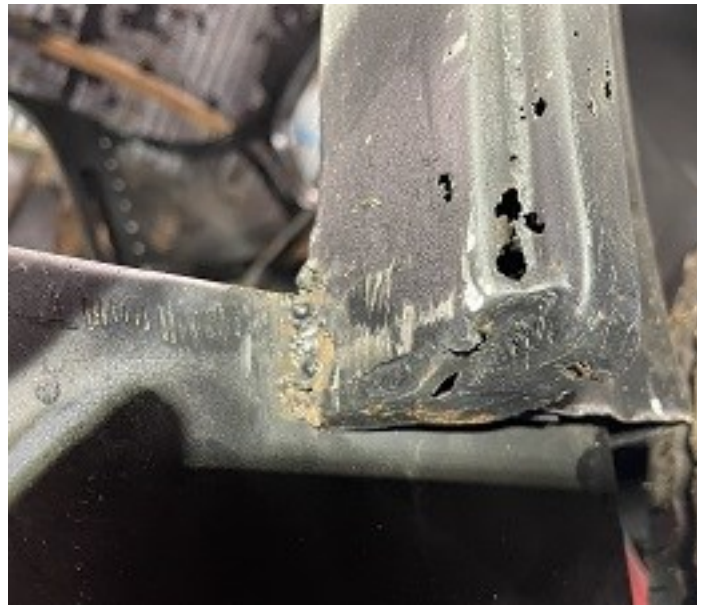
**Above: a few bits to replace**

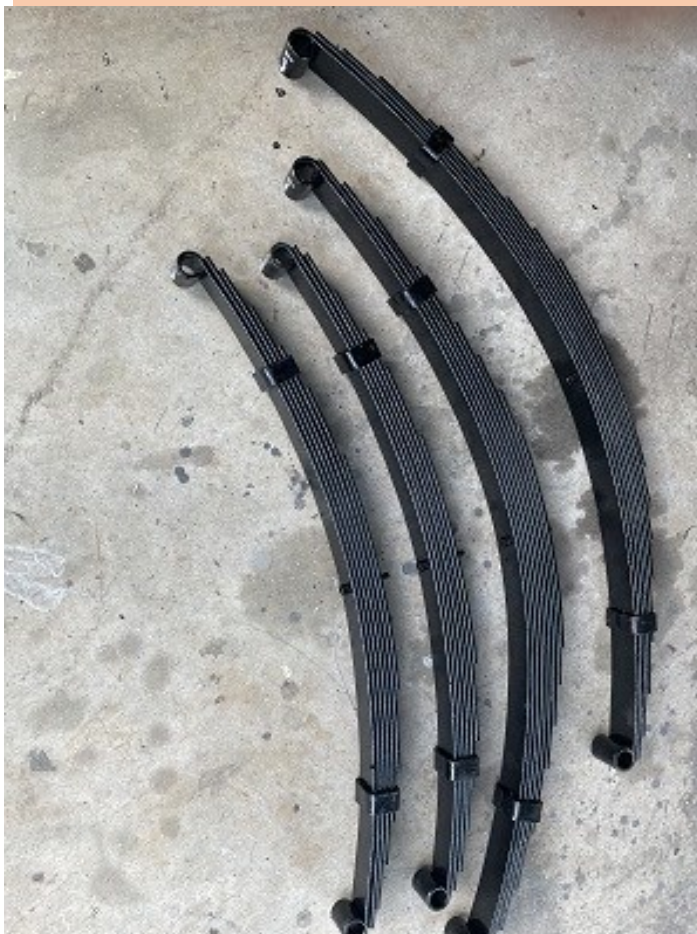
**Adjacent: Christmas is a special time in the year and look what came from the Spring Master this Christmas.**

A little late for assembly prior to Christmas but they will go great with the shackle pins and then the chassis will grow into a Riley.
